# AusNet Services Wood Pole Management

An assessment of sustainable wood pole safety outcomes

Draft for consultation  
Public Technical Report

August 2021

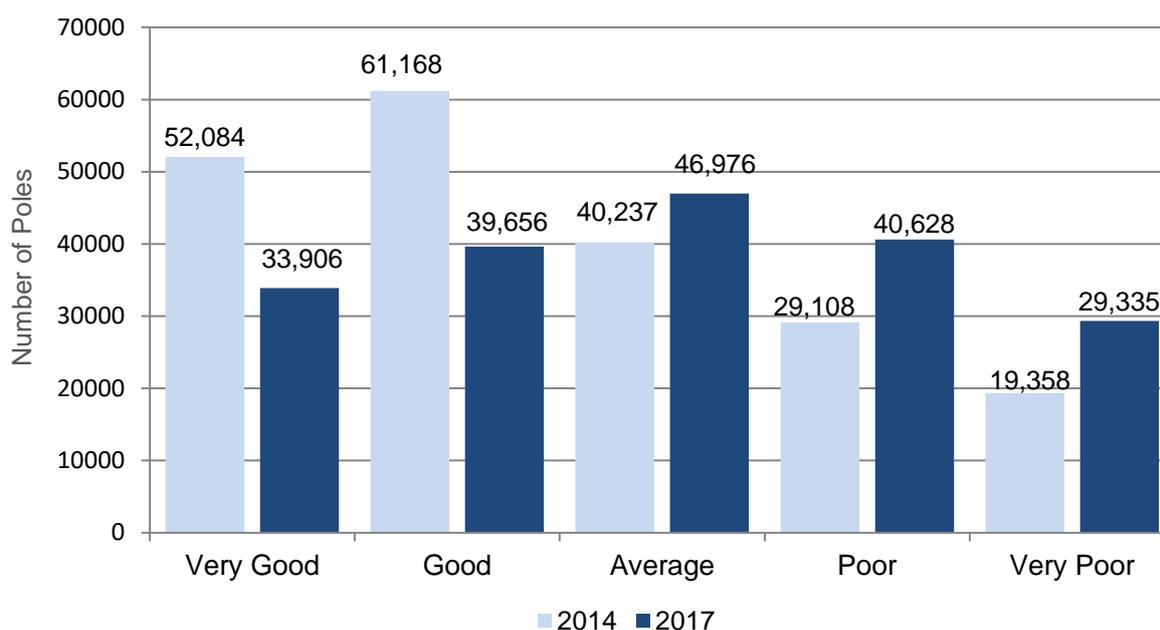
**Figure 4: Comparison of the number of poles by condition score between 2014 and 2017**

ESV has reviewed the condition scoring system for this representation shown in Figure 4 and is comfortable that this generally represent a population of safe wood poles. In addition, ESV has inspected more than 1,000 wood poles during this investigation and those results support this finding.

- 65 per cent of the total pole population has a condition score of “Good” or “Very Good”, however only 39 per cent of wood poles have the same condition score (as shown in Figure 4)
- White Stringybark and Messmate timbers increasingly feature in replacement volumes
- to defer increasing replacement rates the introduction of new wood pole life-extension techniques, including alternative reinforcement methods, rebutting and pole head reinforcement systems will be required.

As shown in Figure 4, AusNet Services has identified that more than 29,000 wood poles have a condition score of “Very Poor”; this means that 15 per cent of the wood pole population will require intervention in a five-to-10 year period. The increasing trend of deteriorated poles shown in this analysis, and the increased volume of poles now in a deteriorated state, suggest that more may need to be replaced in the future to mitigate any increase in safety risk. This hypothesis was tested in the ESV assessment that follows.

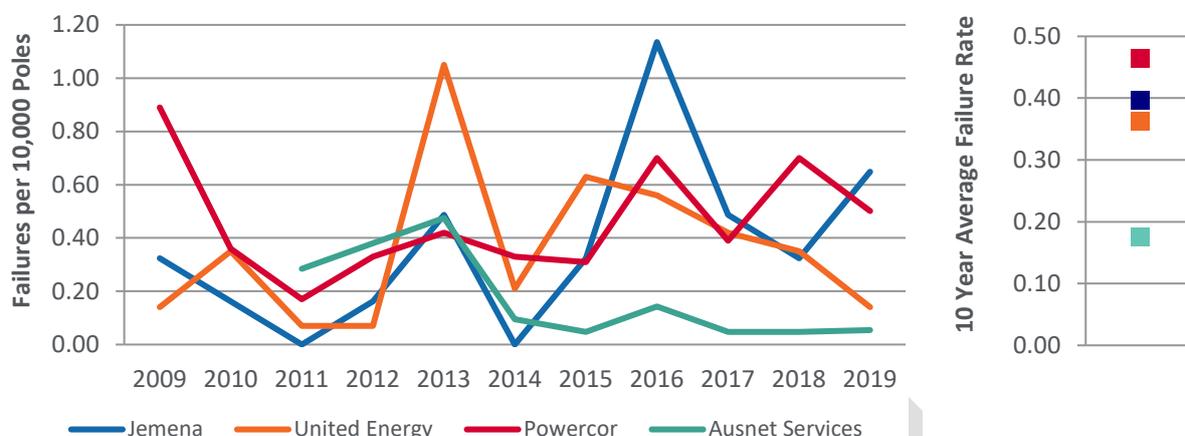
**Figure 5: Comparison of unassisted wood pole failures per 10,000 poles by MEC**

AusNet Services 10-year average of 0.17 unassisted pole failures per 10,000 poles is the lowest of the Victorian MECs presented in Figure 5. AusNet Services has maintained this level of performance or

close to it since 2014. Each MEC’s unassisted wood pole failure statistics were adversely affected by weather events in 2013.

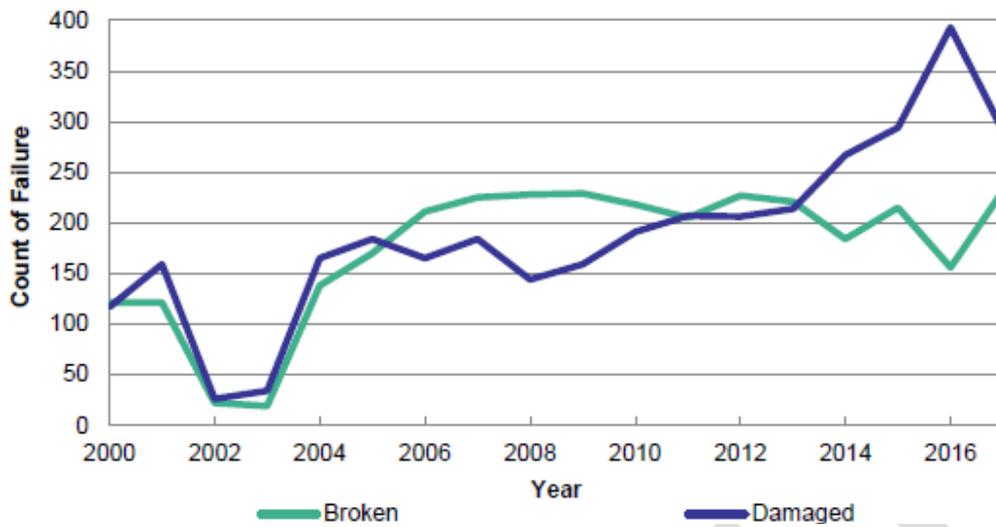
**Figure 6: AusNet Services trend analysis of wood pole failures**

As shown in Figure 6, there has been an increasing trend in the number of damaged poles, while the number of broken poles is relatively constant.

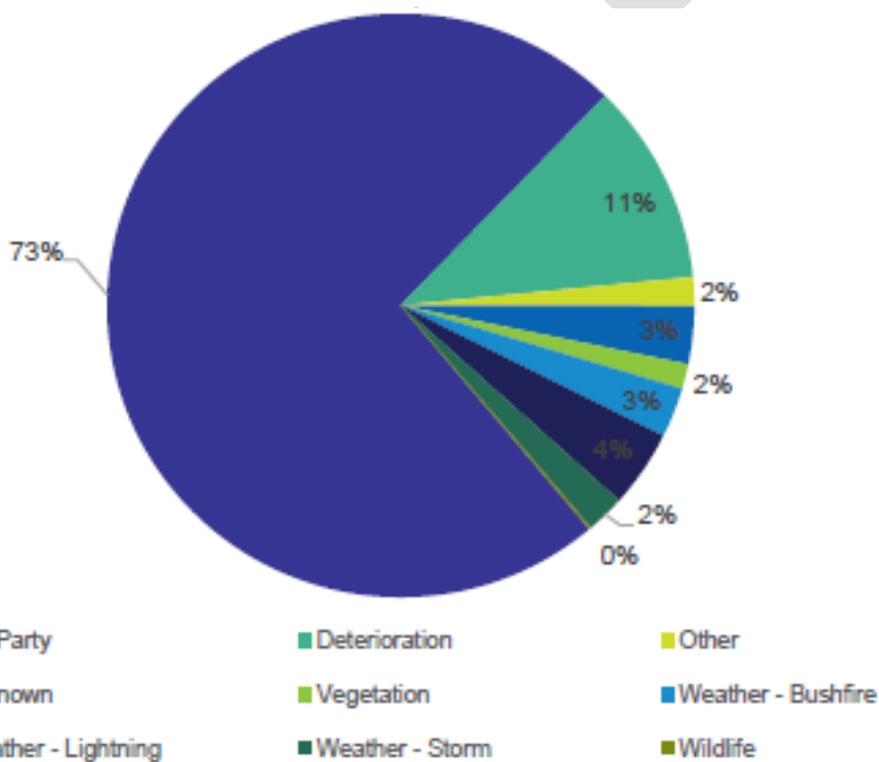
**Figure 7: AusNet Services cause breakdown of wood pole failures**

As shown in Figure 7 the major cause of pole failure is third party damage, comprising 73 per cent, with deterioration at 11 per cent.
