# Low voltage conductor clash

## Vegetation Management Work

### Safety alert

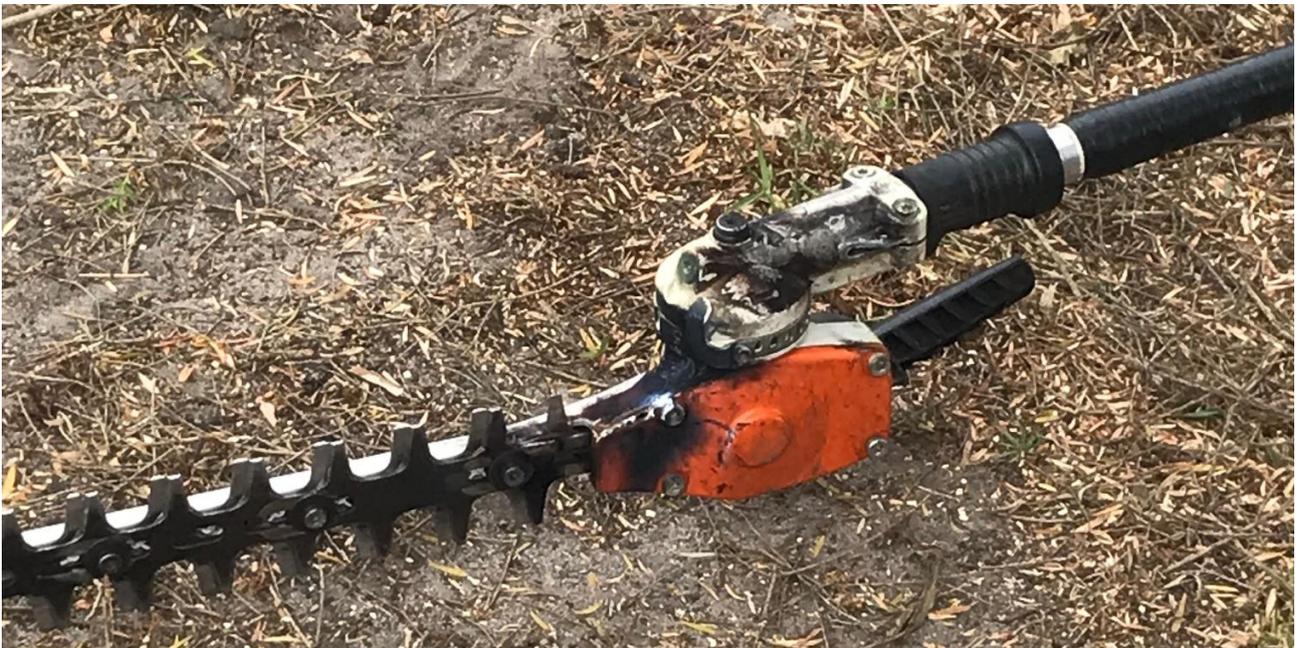
When slewing, the basket of the EWP a hedger tool that was stowed in a vertical position behind the EWP Operator made contact with a bare low voltage (LV) overhead electricity conductor. The EWP Operator and the Safety Observer did not notice this contact. As the EWP Operator continued to slew the EWP basket, the conductor was brought into contact with another adjacent conductor causing them to clash; one of the conductors fell to the ground.

#### Burn marks on hedger tool that contacted LV electricity conductor

- Always maintain the appropriate body and tool Safe Approach Distances when clearing trees to keep them clear of electric lines.
- Regularly reassess worksites for hazards when completing electric line clearance work; particularly when aloft in EWPs.
- Ensure that all personnel are appropriately trained to complete the tasks they are employed to perform.
- Tools and equipment should be securely stowed and checked regularly when working near power lines.
- Make sure Safety Observers are positioned so they can clearly see the whole work environment.
- Make sure personnel are aware of, and inducted into safe work and emergency management procedures.
