# Cut branch falls onto HV conductors

## Vegetation Management Work

### Safety alert

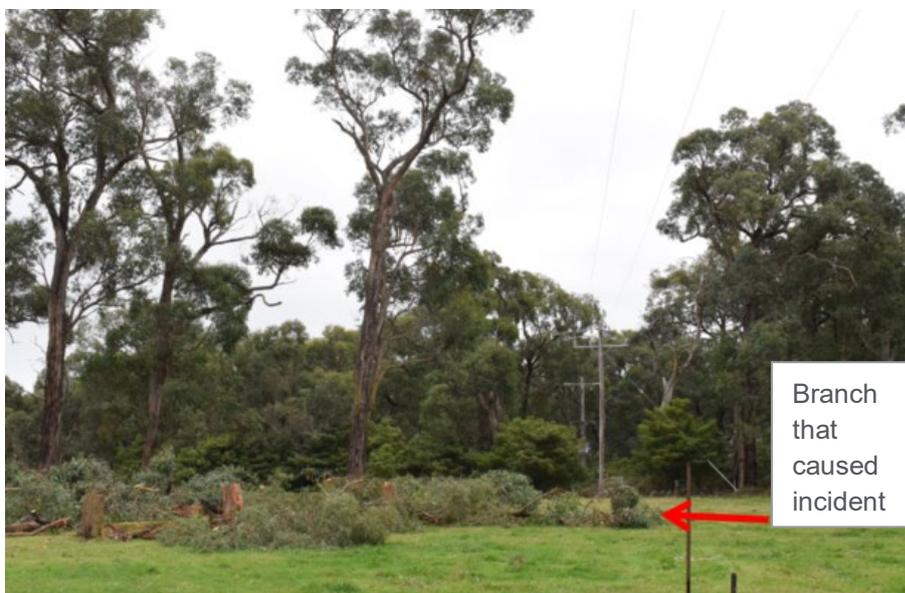
The ground crew worker was removing a branch from a tree adjacent the uninsulated high voltage (HV) conductors; the cut branch fell in an uncontrolled manner onto the HV conductors.

The fallen branch caused the operation of the electricity network protection.

This created an unsafe electrical situation that had the potential to cause property damage, serious personal injury or in the worst circumstance an electrocution. Fortunately no one was injured but electricity supply was disrupted to nearby properties.

- The vegetation management workers failed to maintain the minimum clearances for vegetation management work near protected aerial lines
- The crew failed to complete a site risk assessment prior to commencing the work
- The crew did not identify and outline control measures to ensure the work could be completed safely
- Cutting methods used did not allow for appropriate control of the tree that fell and contacted the HV conductors

- Ensure all site hazards are identified and actions to control the hazards are implemented
- Ensure personnel are qualified and suitably experienced for the task being undertaken
- Always maintain “No go Zone” when undertaking private works in the vicinity of live electrical apparatus
- Regularly reassess each worksite for hazards when completing electric line clearance work
- When planning vegetation management work ensure you assess that the work will remain outside minimum clearances to electric lines; engage with the distribution business if works are required within minimum clearances
