ESV Main subheading

Safety alert

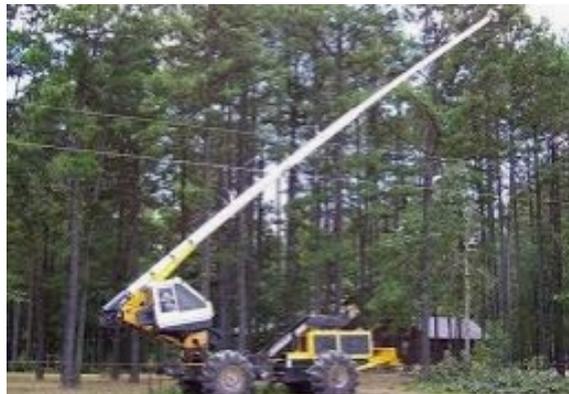
Vegetation management workers were pruning a tree on behalf of an electricity distribution business in a hazardous bushfire risk area as part of a cyclical electric line clearance program. The work was being performed by a vegetation management worker operating a Jarraff tree trimmer similar to that pictured below, example pictured.
