Bendigo Tree Trimming Incident

Vegetation Management Work

Safety alert

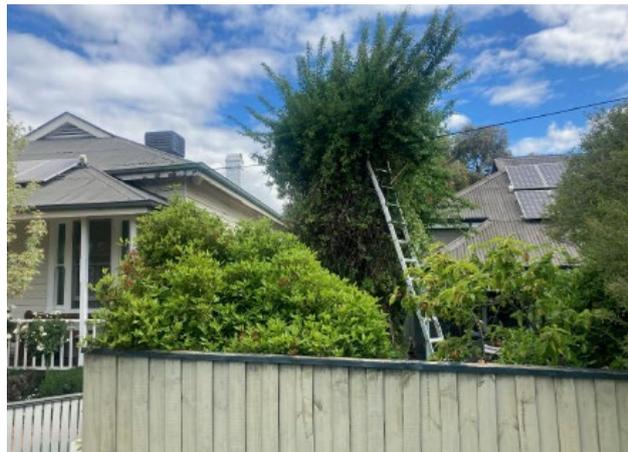
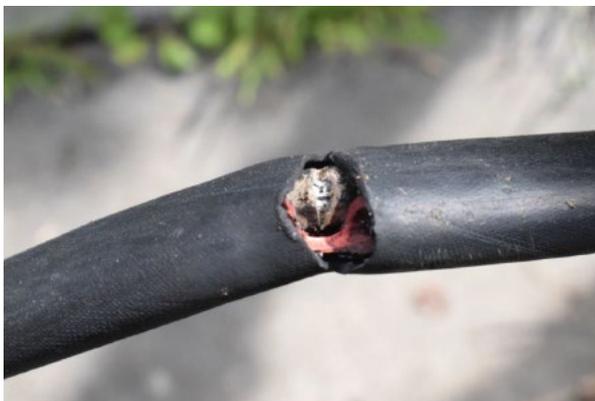
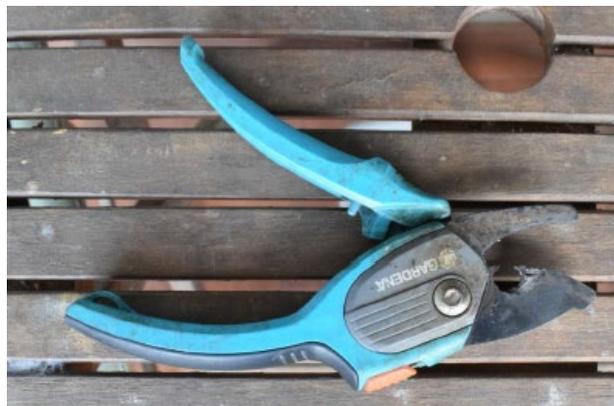
The resident was clearing a tree from a service cable when he made contact with the cable with the secateurs he was using. The contact between the secateurs and electric cable caused an arc flash which caused burn marks on the resident's hand and arm. They were taken to hospital to undergo tests for electric shock and get his burns treated.

This created an unsafe electrical situation that had the potential to cause property damage, serious personal injury or in the worst circumstance an electrocution. Fortunately the resident was not seriously injured but electricity supply was disrupted to nearby properties.

- The resident failed to maintain the minimum clearances for vegetation management work near protected aerial lines
- The vegetation was too close to the LV service cable prior to the incident
- The resident did not identify and outline control measures to ensure the work could be completed safely
- The responsibility for clearing the tree was that of the electricity distribution business as the tree was affecting the neighbours service cable.

- Ensure all site hazards are identified and actions to control the hazards are implemented
- Ensure personnel are qualified and suitably experienced for the task being undertaken
- Always maintain “No go Zone” clearance distances when undertaking private works in the vicinity of live electrical apparatus
- Regularly reassess each worksite for hazards when completing electric line clearance work
- When planning vegetation management work ensure you assess that the work will remain outside minimum clearances to electric lines; engage with the electricity distribution business if works are required within minimum clearances

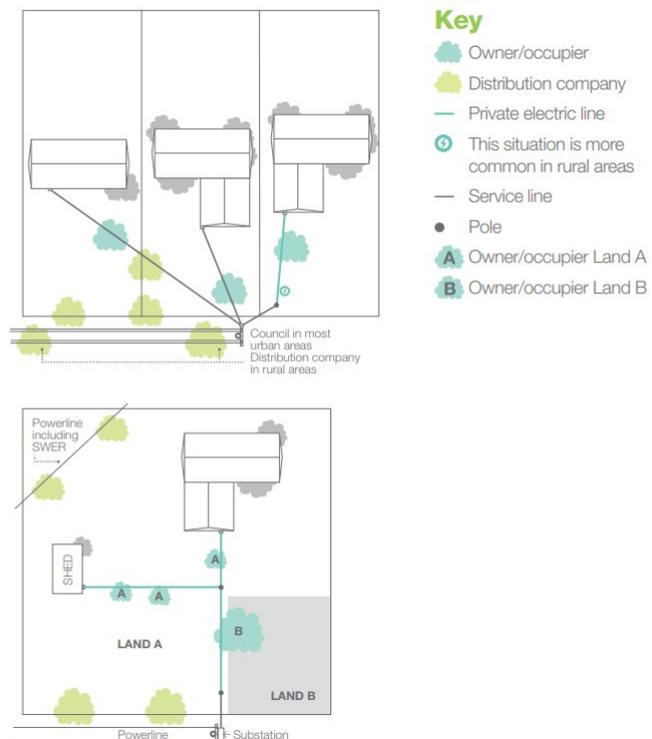
Property owners or occupiers are responsible for keeping trees on their property away from their own service cable. Trees near other electric lines that cross your boundary or trees within your property near the electric lines in the street are the responsibility of the electricity distribution business (AusNet Services, CitiPower, Jemena, Powercor or United Energy) . See diagrams below.

For safety reasons it is recommended that trees be cut before they grow within 1m of an insulated electric service line. If the trees are closer than 1m or if cutting may cause any branches to fall onto electric lines, do not cut them yourself but contact a trained and experienced expert in vegetation management.
