Safety performance report on Victorian electricity networks

November 2021

This report has been endorsed by the Victorian Energy Safety Commission.

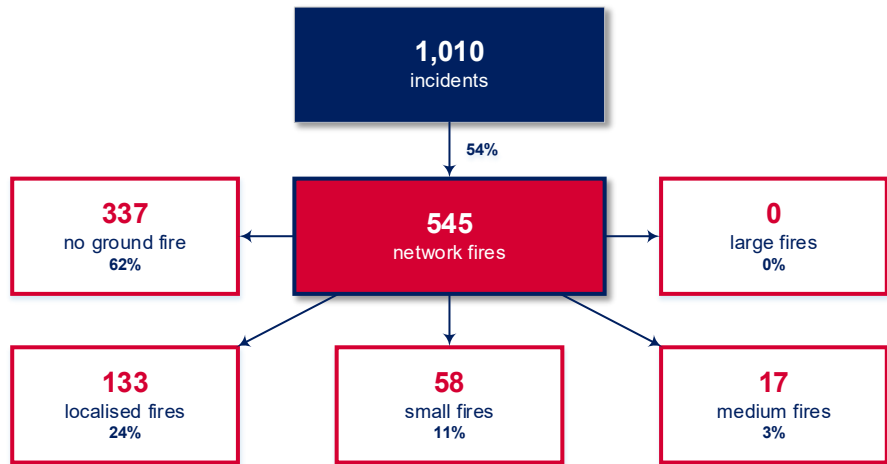
Figure 1 Breakdown of fires by size in 2020-2021¹

¹ Localised = less than 10 m², small = 10-1,000 m², medium = 1,000 m² - 10 ha and large = greater than 10 ha

There were 1,010 reportable incidents involving the electricity networks this year, of which 54 per cent involved a fire. Where fires occur, 62 per cent do not result in a ground fire. The numbers of incidents resulting in a fire are shown in Figure 1, with their relative contributions to total network fires.

There were 111 fewer fires in 2020-21 than in 2019-20, comprising 88 fewer asset fires and 23 fewer ground fires.

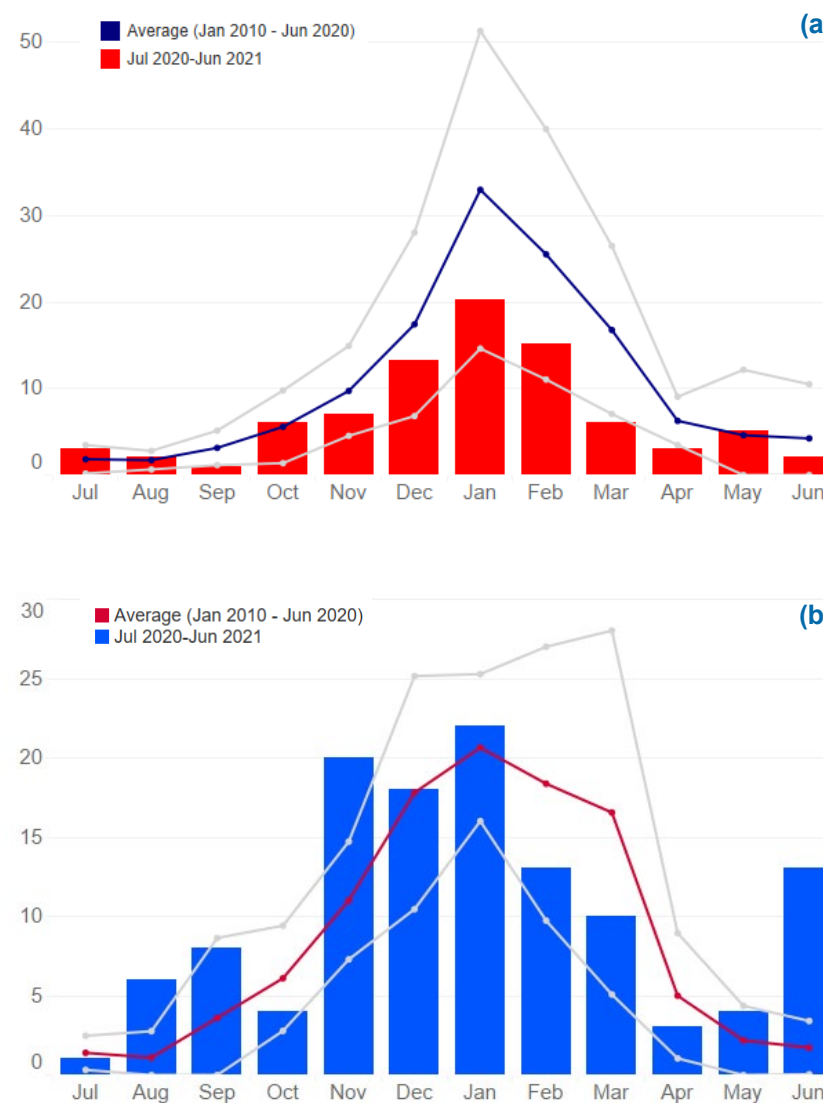
Figure 2 Ground fire incidents due to (a) asset failures and (b) contact events

The grey line is one standard deviation above and below the average

The averages and bounds in Figure 2 show a clear seasonal trend in ground fires due to both asset failures and contact events. Throughout most of the year, there are similar numbers of fires from asset and contact events; however, there is a more pronounced peak in asset-related ground fires in January and February.

The numbers of asset-related ground fires (red bars in Figure 2a) were within one standard deviation of the 2010-2020 average for most of the year. The exceptions were September, March and April, which had fewer fires than expected. The number of fires across bushfire season (November to April) was below the long-term average for each month.

Figure 2b shows that the numbers of contact-related fires were well in excess of the historic numbers in August, November and June. The numbers of fires across most of the bushfire season were in line with historic expectations, with the exception of November.

The outlier in Figure 2b is the peak in June that is well above the normal band of expected fires. Of the 13 contact-related fires in June 2021, tree contact was the cause of five fires on 9 June (all on the United Energy network) and four fires on 10 June (three on the United Energy network and one on the AusNet Services network). These incidents coincided with a major storm event that swept across Victoria, with much of the damage in the Dandenong Ranges and Bass Coast. At its peak, approximately 300,000 customers had lost supply due to wind gusts of 100-140 km per hour, which brought down trees and powerlines.

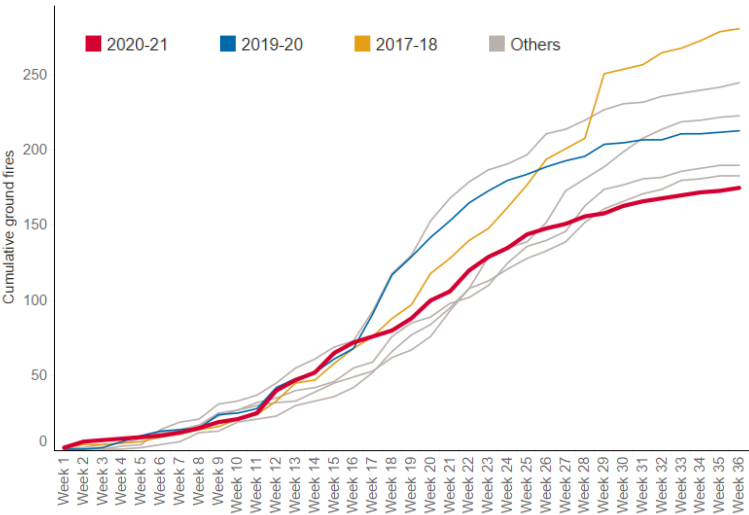
Figure 3 Cumulative fires across the fire season

Figure 3 shows the cumulative number of ground fires throughout the fire season (October to April). While the total fires in the first 15 weeks of the fire season were similar to 2019-20, there was no increase in fires in the second half of the season similar to that seen in 2019-20 and other seasons.

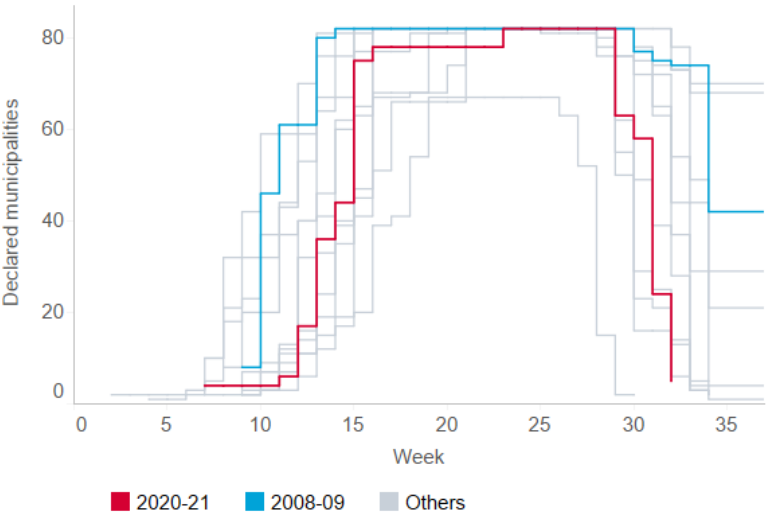
Figure 4 Summary of CFA fire declarations from 2008 to 2021

The first declarations for this year's season started later than last year, but still weeks earlier than most previous seasons (Figure 4). Despite these initial declarations, the escalation of declarations was much slower than for the 2008-09 bushfire season (Black Saturday). Full declaration was much later this season and was short-lived, with declarations being removed quickly soon after full declaration. The official fire season finished several weeks earlier than previous years.

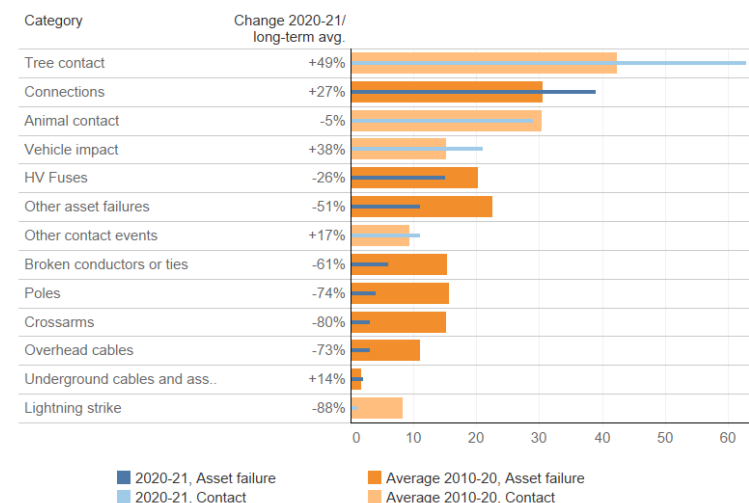
Figure 5 Ground fire-related incidents occurring on Victorian networks

Figure 5 shows the number of ground fire events on the Victorian networks from most common to least common this year (blue bars) relative to the long-term average for the 2010-2020 period (orange bars).

The four most common causes of fires were tree contact, connection faults,² animal contact, and vehicle impacts. The same three events comprised last year's top three causes of fires, with vehicles impacts replacing other asset failures in fourth position.

After last year's increase, tree contact fires have risen again this year (Figure 6) and continue to be 49-50 per cent above the long-term average for the second year running (Figure 5).

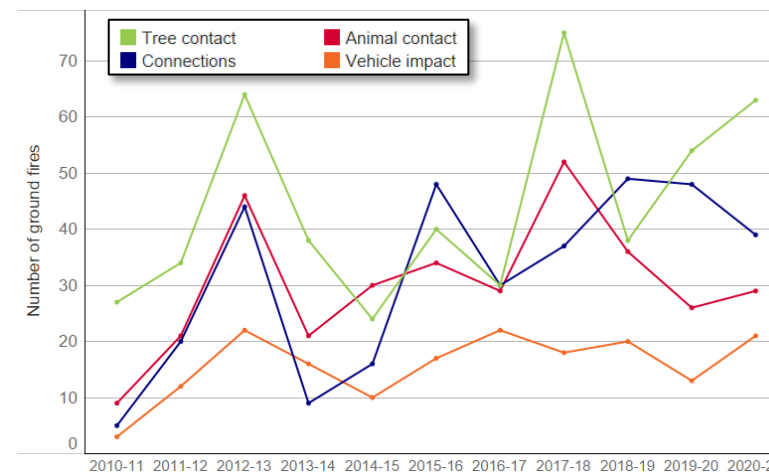
Figure 6 Historic trends for common ground fire events

Figure 6 shows the trend over the last eleven years for the four most common causes of ground fires. This indicates that:

- fires from tree contact have increased again this year and are now 49 per cent above the historic average, mostly due to vegetation blowing and falling onto powerlines from outside the clearance space
- after rising steadily since 2013-14, fires from connection faults have fallen this year but are still 27 per cent above the historic average (last year they are 67 per cent higher)
- animal contact fires increased slightly this year and are now 5 per cent below the historic average (16 per cent below last year)
- fires from vehicle and equipment contacts increased this year and are now 38 per cent above the historic average.

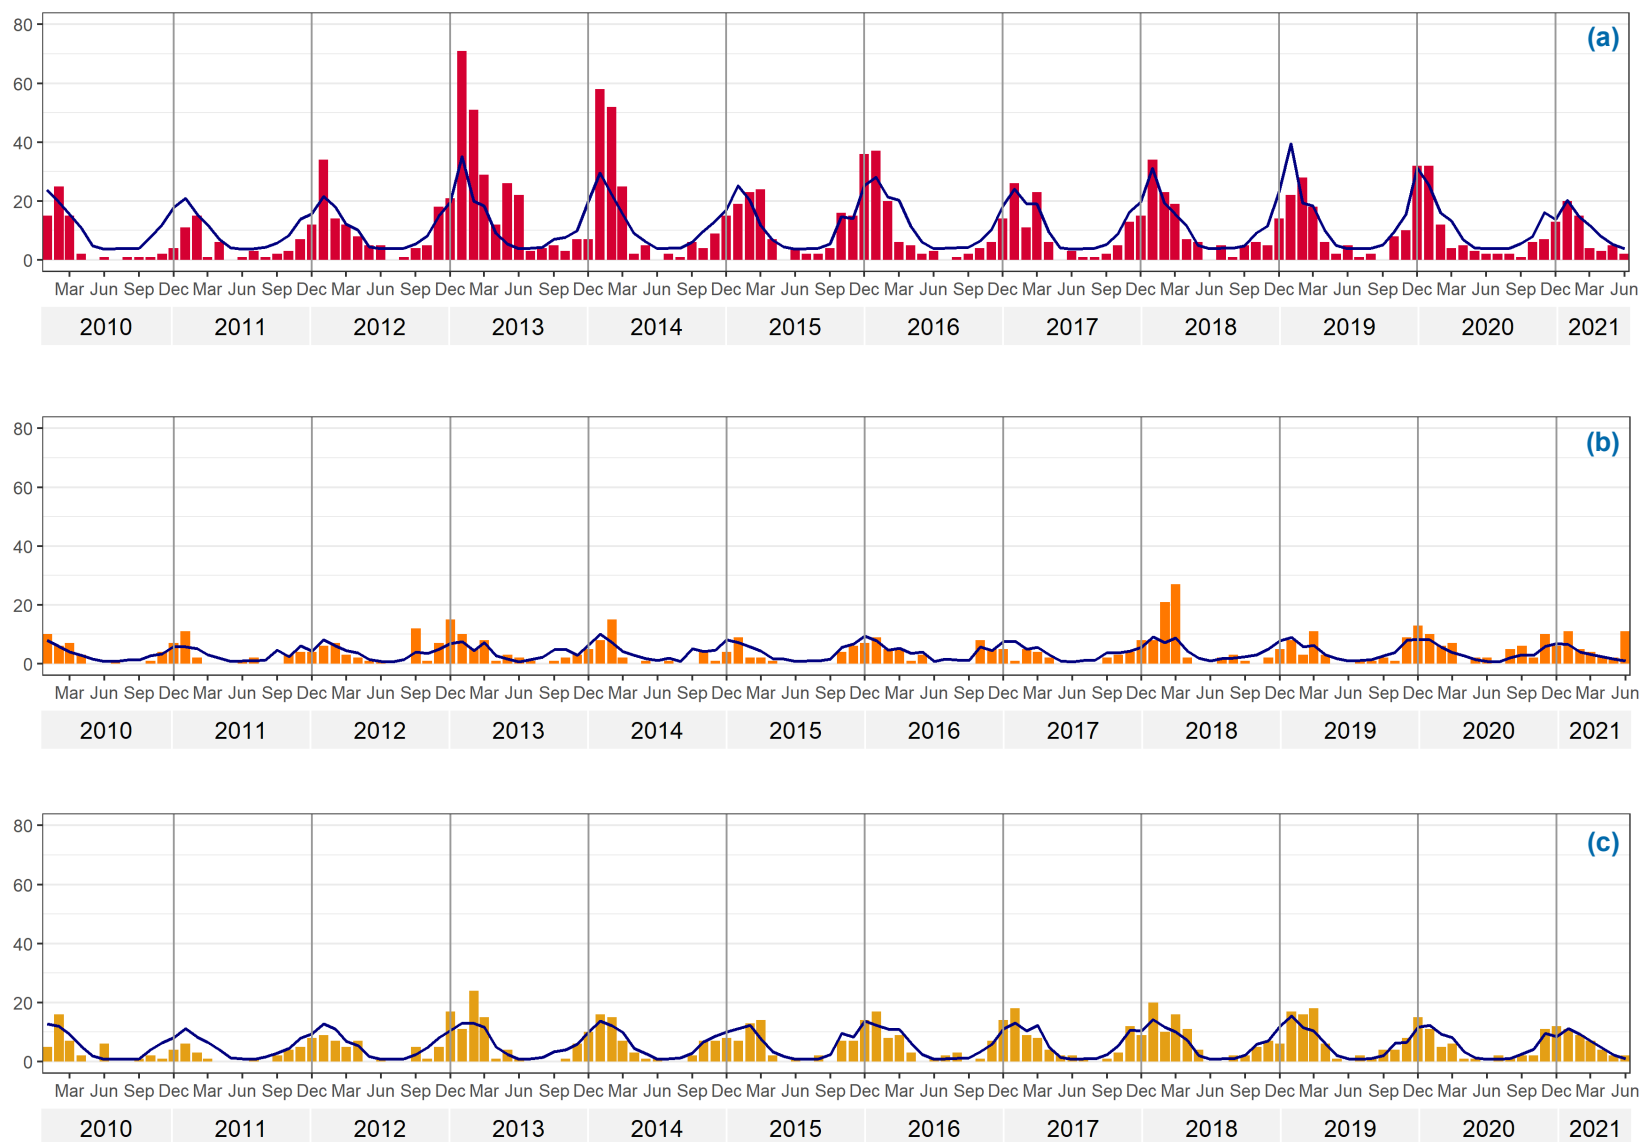
Figure 7 Influence of weather on ground fires due to (a) asset failures, (b) vegetation contact and (c) other contact events

Separate models have been developed for ground fires due to asset failures (Figure 7a), vegetation contact (Figure 7b) and other (non-vegetation) contact events (Figure 7c). The models predict the number of each type of incident based on daily weather observations from the nearest of 37 Bureau of Meteorology stations. The actual numbers of ground fires are then aggregated by month and shown as coloured bars in each of the figures; the prediction is shown as a blue line. The blue line also differs between the three figures due to variations in the mix of weather factors driving each model's prediction.

All three event types naturally follow a seasonal trend with peaks in summer and troughs in winter. The seasonality is most pronounced in the asset failure fires and least pronounced with the vegetation fires. The latter is possibly due to clearance programs reducing the impact of vegetation growing into the powerlines, which leaves the residual impact primarily from blown branches and fallen trees associated with storm fronts.

The major exceedances in the summer of 2012-13 (see Figure 7a) were due to an extremely hot summer across the southern half of Australia, with a new national average maximum being set on 7 January 2013 and six of the 20 hottest days in Australian records occurring in January 2013. This not only raised the potential for bushfires, but also put greater stress on network assets that may have contributed to their failure, particularly when combined with higher electrical demand (from air-conditioning, for instance).

Similarly, Figure 7b shows peaks in February and March 2018. These may be due to:

In general, the predictions reflect the shape and structure of the peaks in the incident data, and are close matches with the actual number of fires.

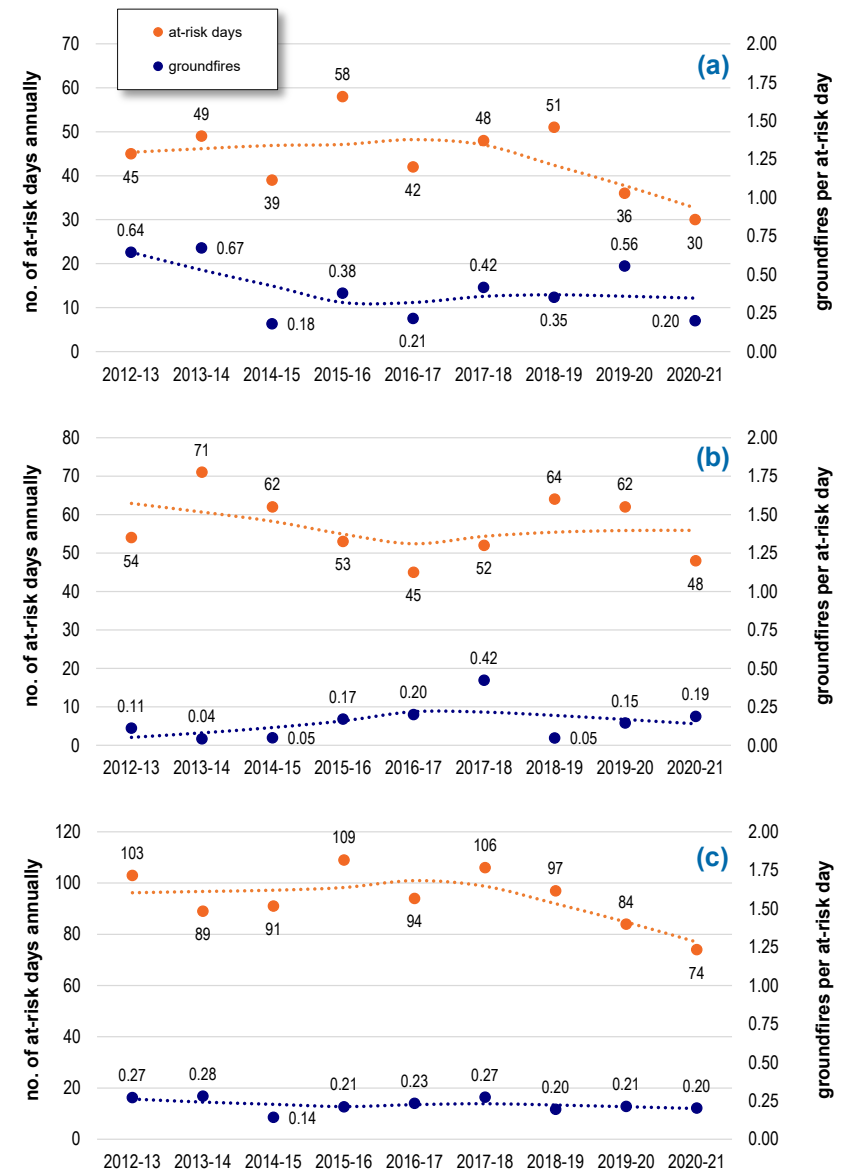
Figure 8 Numbers of ‘at risk’ days each year and the associated rate of incidents in HBRA on those days for (a) asset failures (b) vegetation contacts and (c) other contacts

Figure 8 shows the numbers of at-risk days for ground fires against the number of fires per at-risk day in HBRA for the three event types. This shows that:

- the numbers of at-risk days has decreased since 2017-18 for asset failures and other contact events, while the at-risk days for vegetation contact fires has been relatively stable
- the rate at which ground fires occur on at-risk days has been stable for asset failures and other contact events, and decreasing for vegetation contact fires
- the number of at-risk days each year for other contact fires is about 1.5 times larger than for vegetation contact fires, and more than twice as many days than for asset failure fires.

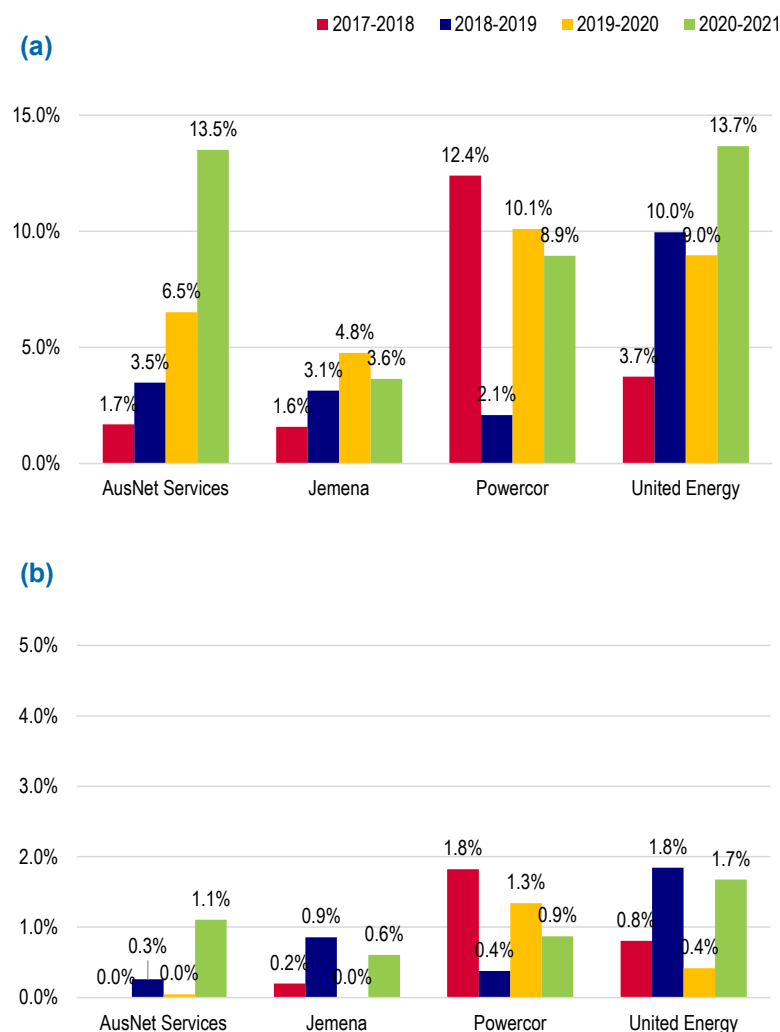
Figure 9 Non-compliance rates in HBRA
(a) all non-compliances and (b) major non-compliances

ESV has seen an increase in the rates of non-compliant vegetation across the networks in HBRA for a third consecutive year (Figure 9a), with this year's increase due to the poor performance of AusNet Services and United Energy. Both Jemena and Powercor improved when compared to last year.

The rate of major non-compliances affecting the networks (that is, instances where vegetation was at imminent risk of contact with powerlines) also increased in HBRA when compared to last year (Figure 9b).

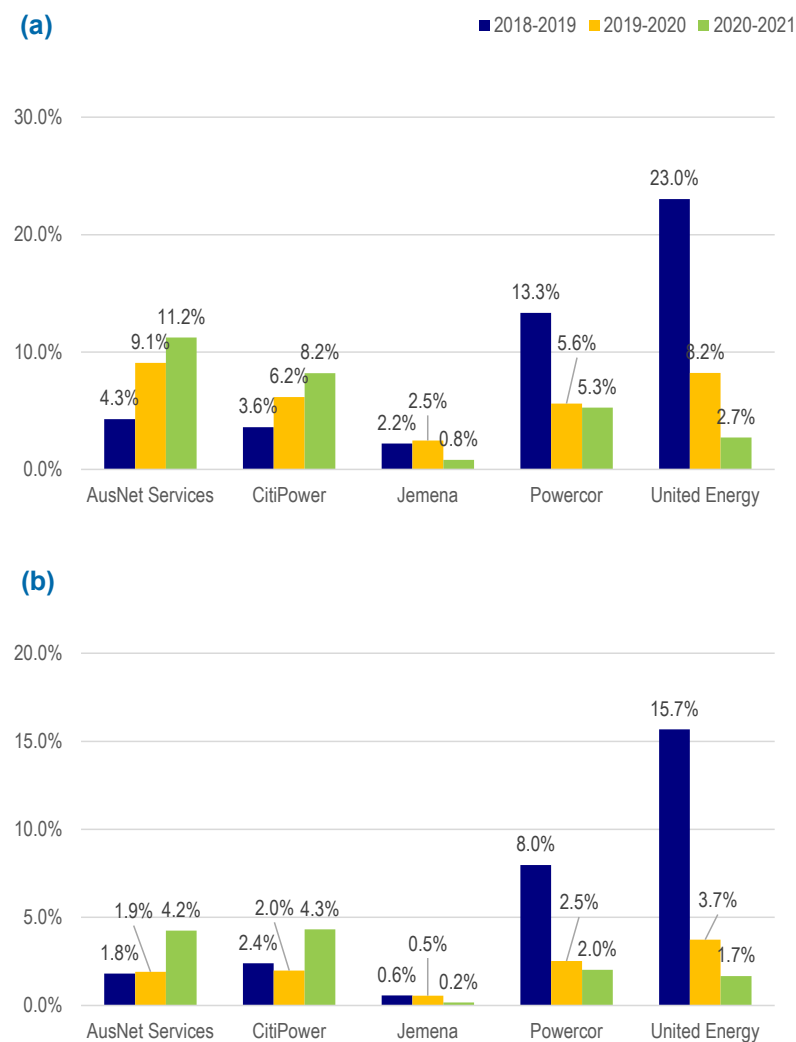
Figure 10 Non-compliance rates in LBRA
(a) all non-compliances and (b) major non-compliances

The rate of non-compliant vegetation affecting the distribution networks in LBRA was marginally worse than the previous year. The increase in non-compliance was directly due to the declining performance of AusNet Services and the smaller CitiPower; compliance standards in LBRA improved for each of the other distribution businesses (Figure 10a).

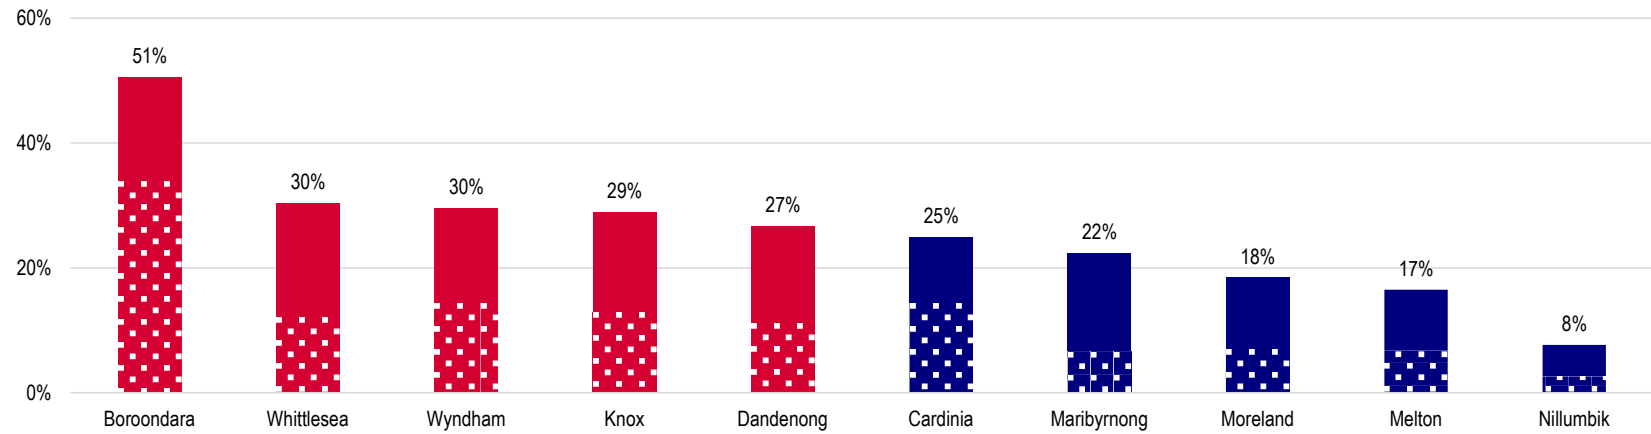
Figure 11 Non-compliance rates for councils inspected in 2020-2021

The councils shown in red had non-compliance rates in excess of the council average. The dotted area shows the levels of high risk non-compliance within the overall non-compliance rate.

During the 2020-21 period, ESV identified 923 non-compliant spans across the 10 councils it inspected in that period (Figure 11). All the non-compliant spans identified by ESV are issued to the responsible council by notice made under section 86(1) of the Act, which requires clearing of vegetation in timeframes specified by ESV.

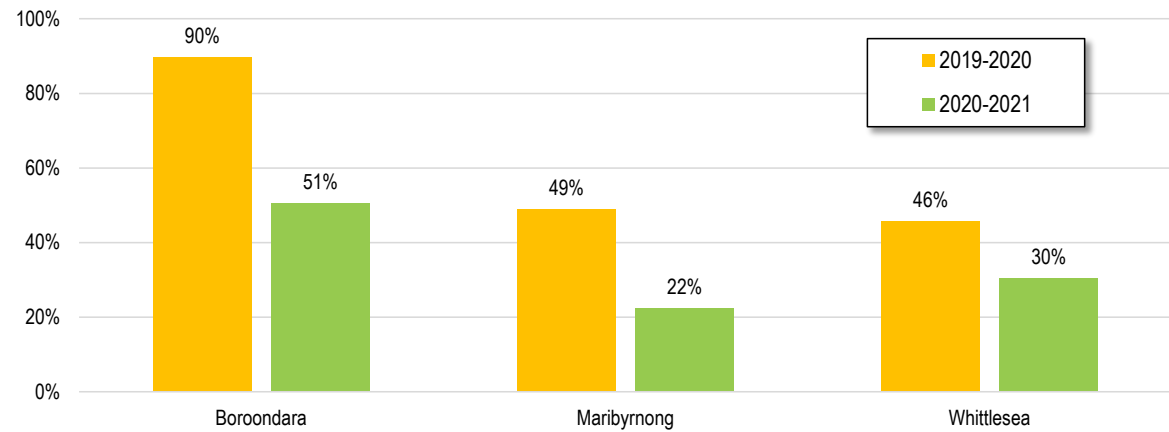
Figure 12 Performance improvement of three worst-performing councils from 2019-2020

It was pleasing to note that each of these councils had responded by showing vastly improved compliance standards; greatly improving electricity safety in these municipalities (Figure 12).

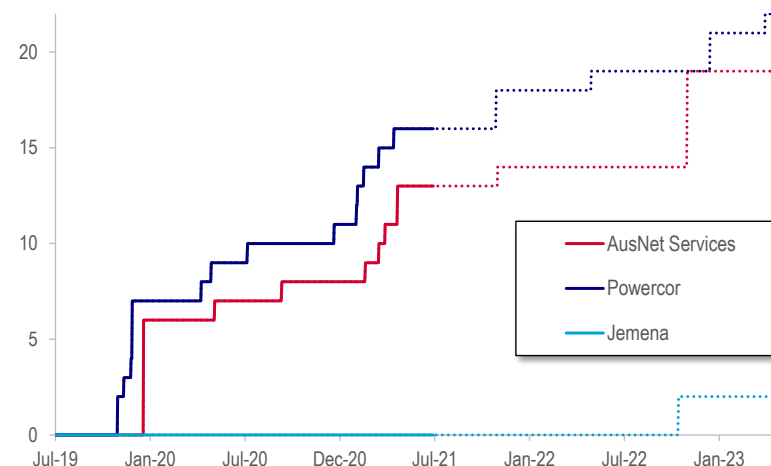
Figure 13 Compliant REFCLs installed to 30 June 2021

Dotted lines are projected delivery times

By 30 June 2020, ESV had accepted 13 AusNet Services zone substations and 16 Powercor zone substations as compliant. Figure 13 shows the cumulative number of compliant REFCLs installed by each major electricity company and the anticipated progress to achieving full compliance at all mandated substations. Figure 14 shows the coverage of the substations with REFCLs mandated by the regulations.

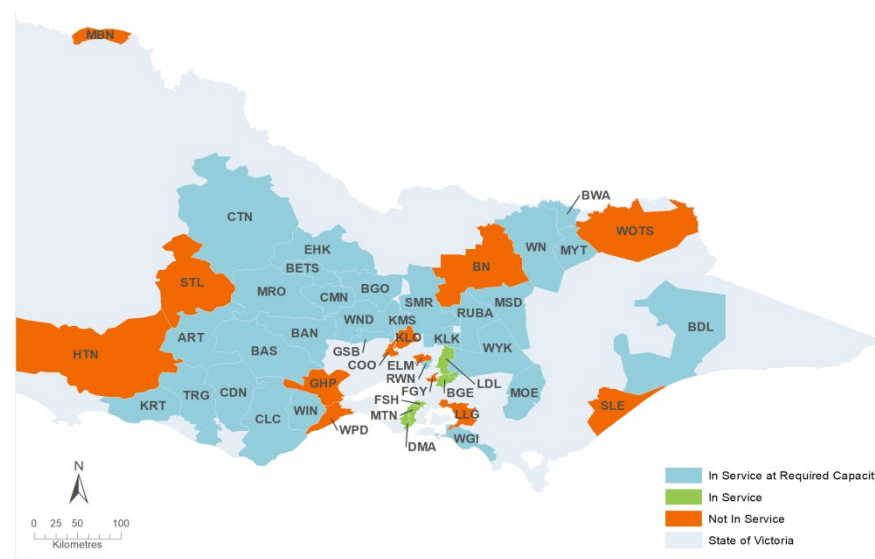
Figure 14 Mandated REFCLs and their status at 30 June 2021

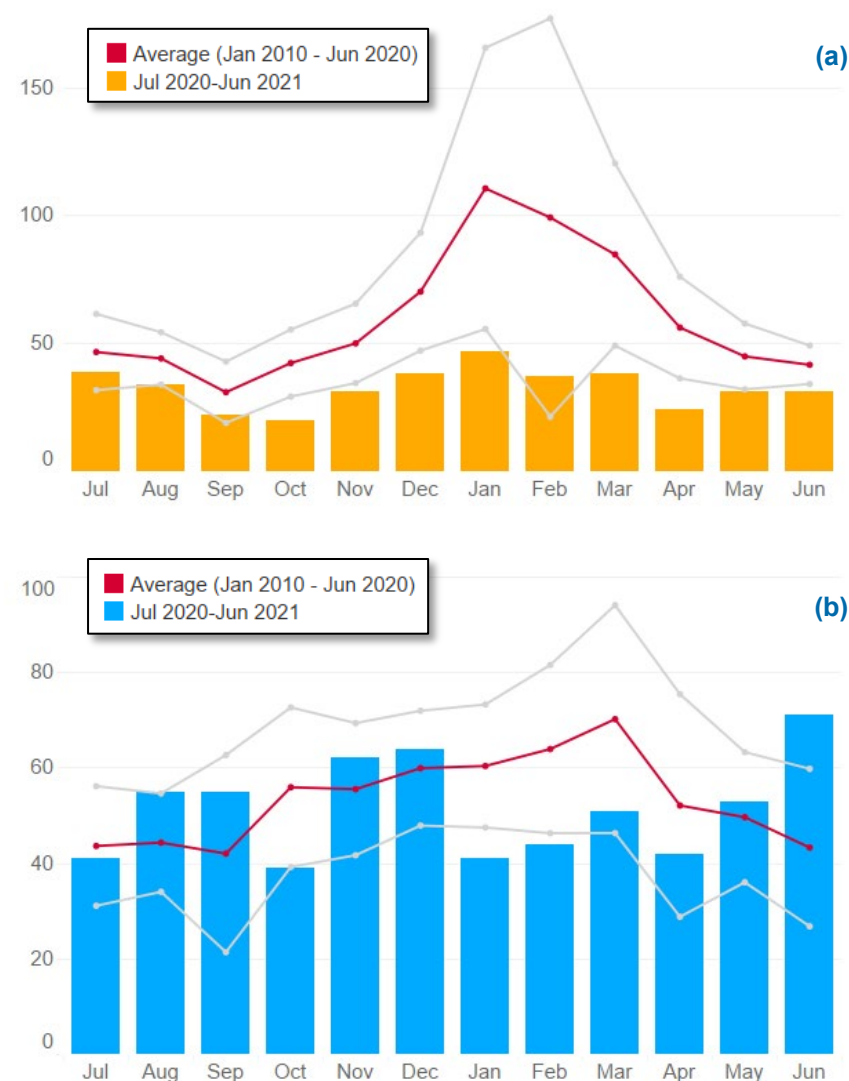
Figure 15 All incidents in the period due to (a) asset failures and (b) contact events

The grey line is one standard deviation above and below the average

Figure 15 shows the number of network safety incidents on the Victorian networks. The numbers of asset failure incidents and contact events are reported separately.

The historical average for the period January 2010 to June 2020 shows a seasonal trend with increased asset failures over the summer period (Figure 15a). The numbers of asset failure incidents in the last year were well below the 2010-2020 average, with eight of the 12 months being more than one standard deviation below the average. The annual peak that normally occurs in January and February did not occur in 2020-2021.

The numbers of contact events show less seasonality and a less pronounced peak occurring in March (Figure 15b). Such events are largely outside the direct control of the networks to manage.

Contact events this year also showed a high degree of variability. Two months were more than one standard deviation below the long-term average, and one month was higher than one standard deviation above the average.

The peak in June 2021 was primarily a spate of tree contact incidents associated with a major storm front that crossed Victoria on the 9-10 June (see page 12).

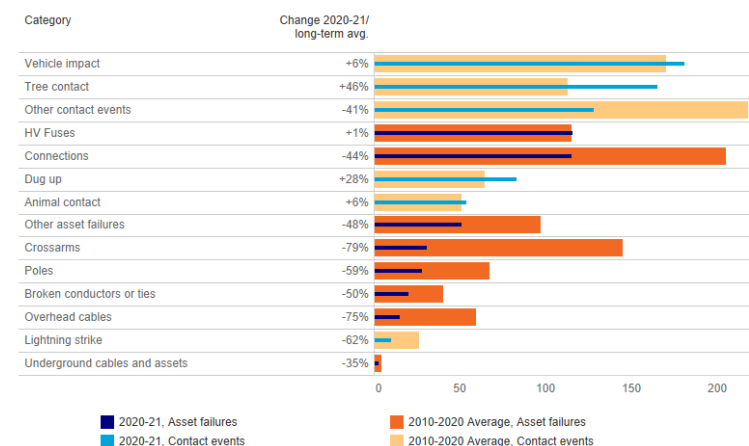
Figure 16 Incidents occurring on Victorian networks

Figure 16 shows the number of incidents on the Victorian networks from most common to least common this year (blue bars) relative to the long-term average for the 2010-2020 period (orange bars).

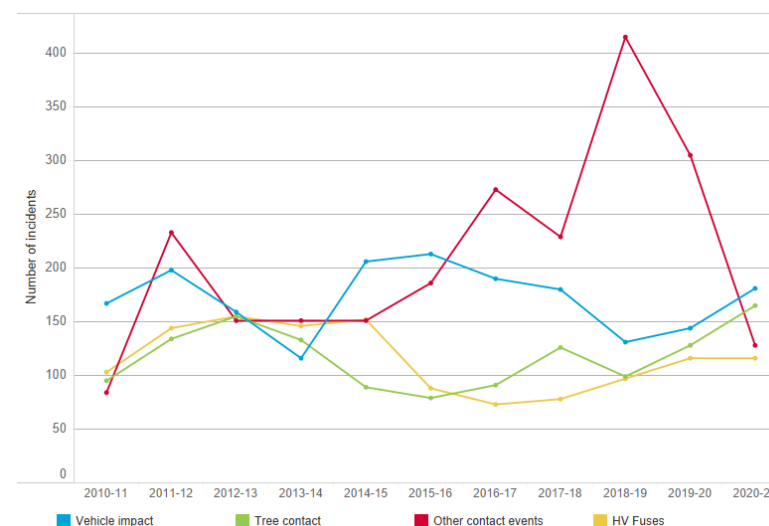
Figure 17 Historic trends for common incident events

Figure 17 shows the trend over the last ten years for the top four events above. This indicates that:

- vehicle impacts on overhead lines and poles have increased
- tree contacts have also increased this year
- other contact events have decreased markedly this year
- HV fuse faults have been stable.

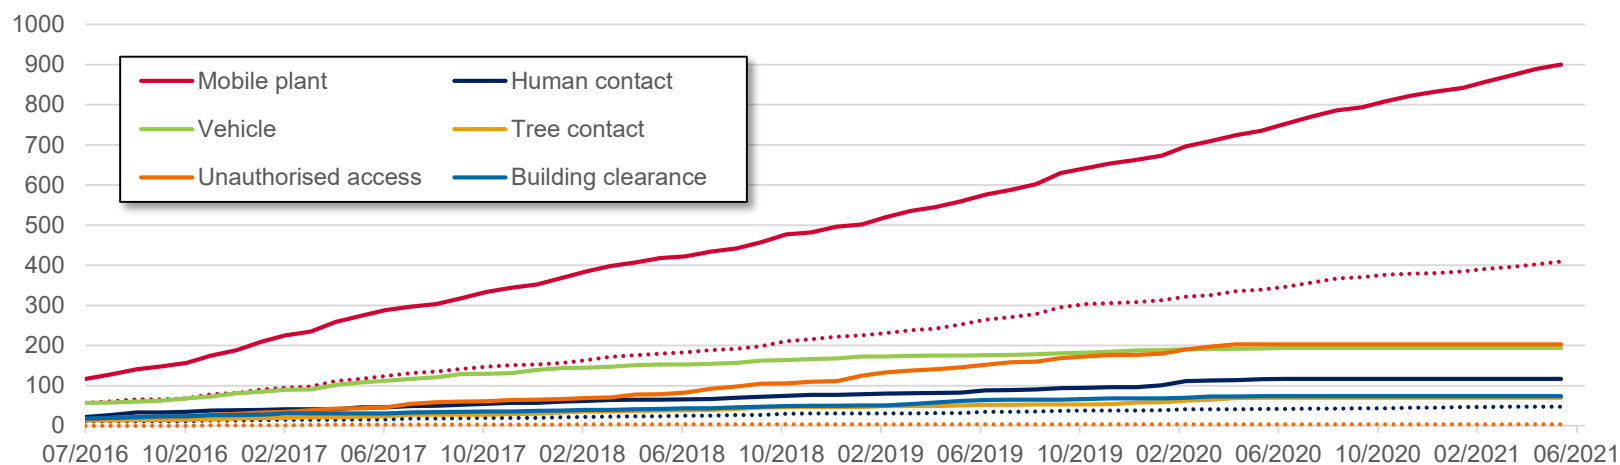
Figure 18 Cumulative trends involving NGZ incidents since 1 October 2015

solid lines = overhead assets, dotted lines = underground assets

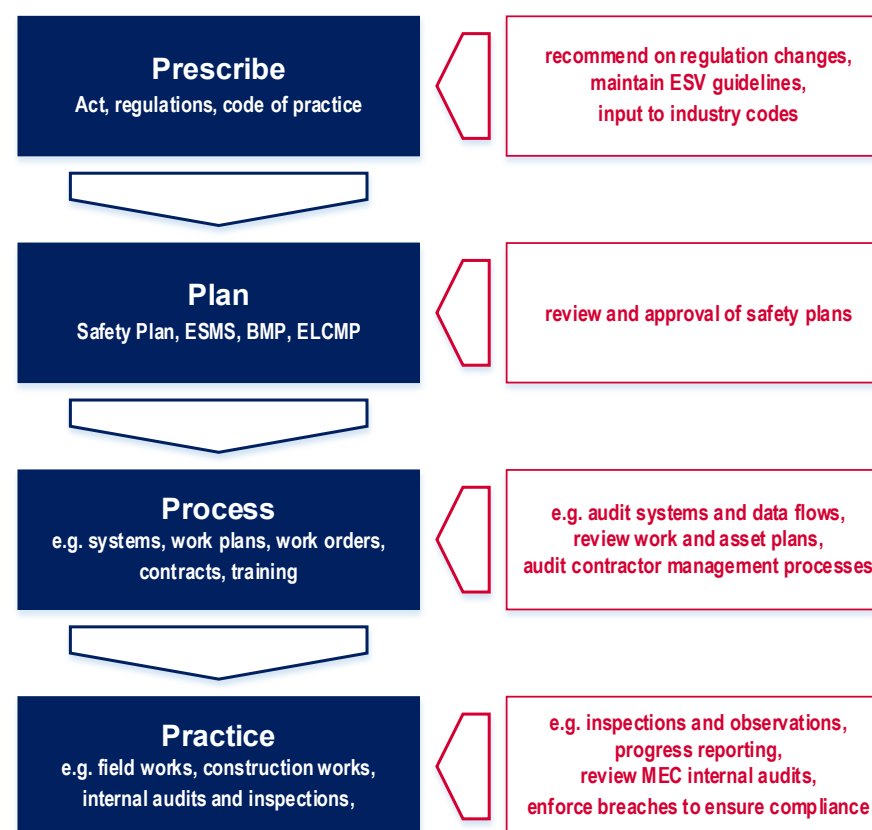
Figure 19 The regulatory hierarchy of controls

ESV undertakes a wide range of functions to ensure safety risks are being appropriately managed by the Victorian transmission and distribution networks. Figure 19 shows an idealised hierarchy of controls, illustrating how the *Electricity Safety Act* and associated regulations flow down through the various plans into processes, and are finally deployed as practices on the ground. The blue boxes designate the levels within the hierarchy and examples of elements at each level.

As regulator, ESV attempts to gain insight into the various levels of the hierarchy to ensure that failures at the top levels don't manifest at systemic issues at the lower levels. Examples of the tools we use to gain insight are shown as the red boxes in Figure 19.

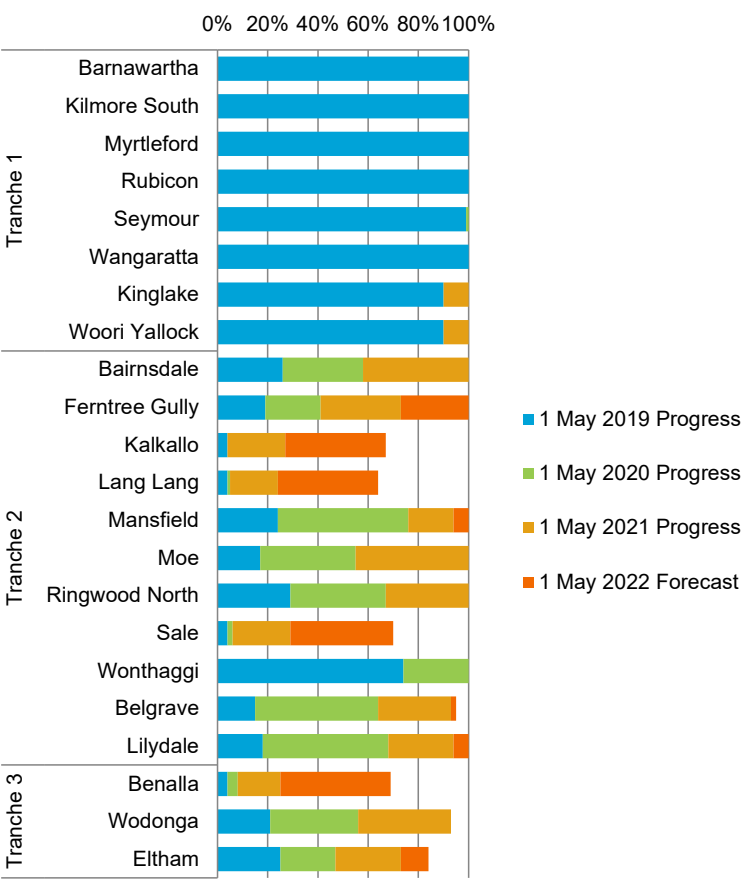
Figure 31 shows the progress of the AusNet Services REFCL installation program as of 1 May 2019, 2020 and 2021, and its anticipated progress in the next twelve months.

By 30 June 2021, ESV had accepted 13 AusNet Services zone substations as compliant, and granted time extensions in relation to four zone substations.

AusNet Services has experienced technical challenges in achieving the required capacity on some feeders with a high proportion of single-phase spurs, feeders that are excessively long and/or feeders that experience mutual coupling effects due to proximity to transmission or sub-transmission lines. AusNet Services is undertaking modelling and has engaged global experts in this field to address the issue.

Figure 31 Status of the AusNet Services REFCL program

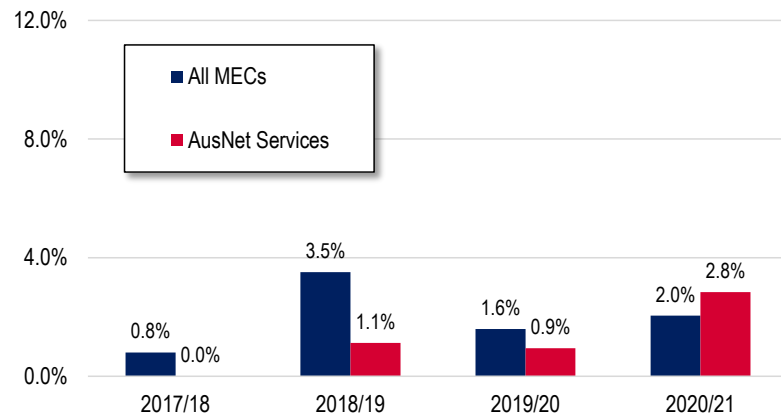
In 2020-21, ESV observed a significant rise in the rate of major non-compliances affecting the AusNet Services distribution network (Figure 32). A major non-compliance is regarded as high risk where vegetation is touching, or could soon touch, uninsulated conductors.

Figure 32 Rate of major non-compliances (HBRA and LBRA)

A progressive decline in the performance of AusNet Services has been observed since 2017-18 (see Figure 9 and Figure 10); with a significant further deterioration observed this year.

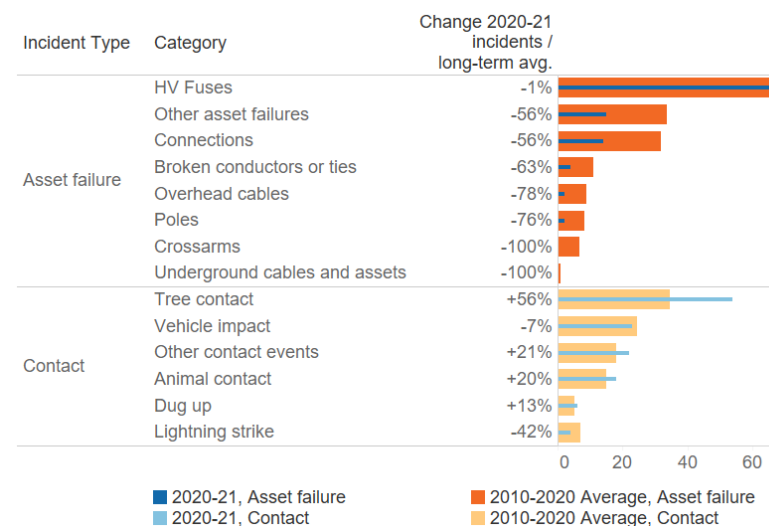
Figure 33 shows the number of all serious electrical incidents reported to ESV via OSIRIS by AusNet Services during the 2020-2021 period, with the blue bars showing the numbers for 2020-21 and the orange bars showing the long-term average from 1 October 2010 to 30 June 2020. Figure 34 shows the same for those incidents that resulted in a ground or vegetation fire.

Figure 33 Incidents on the AusNet Services network

Tree contact, animal contact, connection faults and HV fuse failures were the most common causes of network-related fires. Fires from asset failure incidents were lower in 2020-21 than the long-term average in all categories. Fires from contact incidents were higher than the long-term average in three categories (tree contact, other contact events and vehicle impacts) and lower in two categories (animal contact and lightning strike).

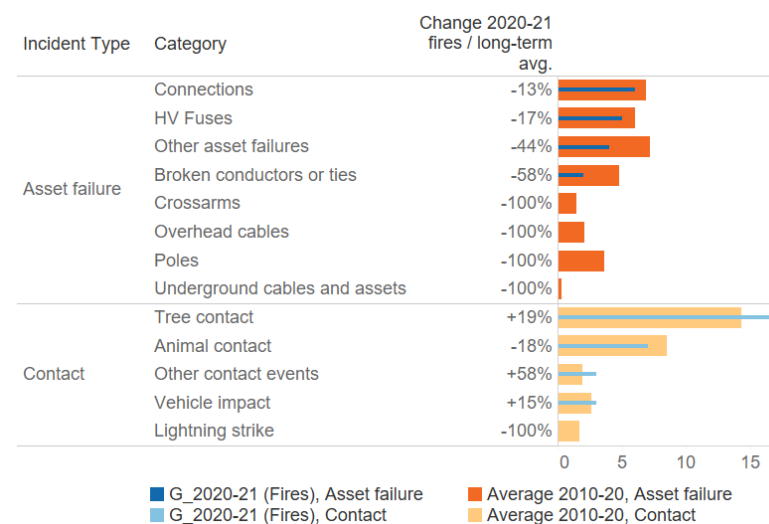
Figure 34 Incidents on the AusNet Services network resulting in ground fires

While tree contact events are partly within the control of AusNet Services, such events are not fully within its control when they involve vegetation that has blown or fallen onto powerlines from outside the clearance space.

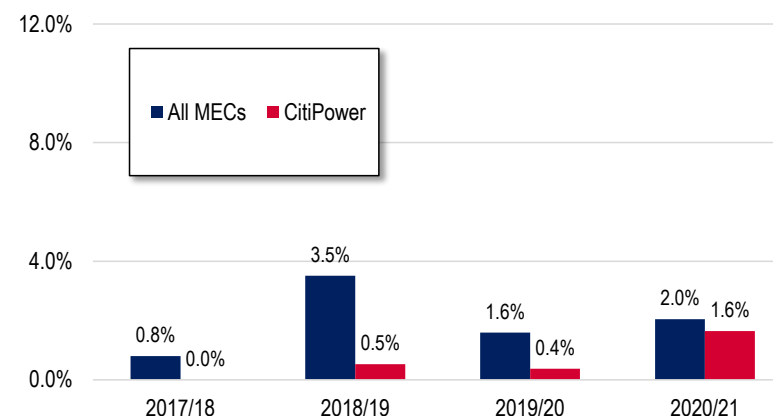
Figure 37 shows the rate of major non-compliances on the CitiPower network. While the rate of major non-compliance on the CitiPower network has been lower than the average across all of the distribution networks each year since ESV commenced collecting this data in 2017, ESV has noticed that there was an increased rate of non-compliance in 2020-21.

Figure 37 Rate of major non-compliances (LBRA)

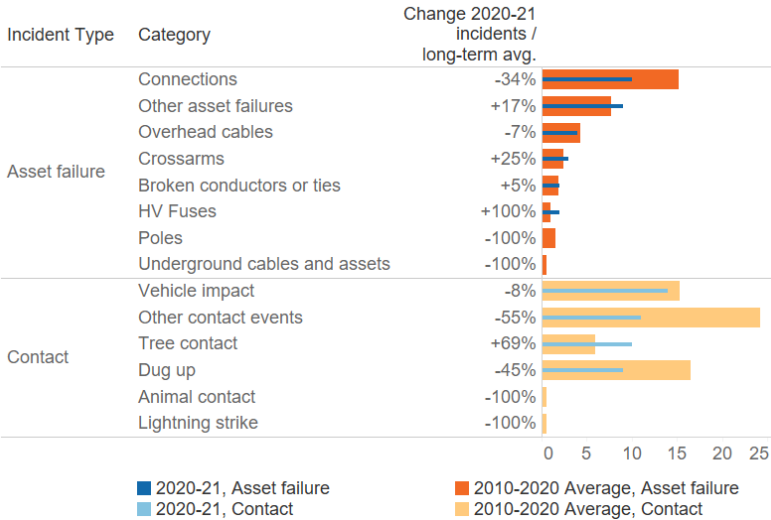
Figure 38 shows the number of all serious electrical incidents reported to ESV via OSIRIS by CitiPower during the 2020-21 period, with the blue bars showing the numbers for 2020-21 and the orange bars showing the long-term average from 1 October 2010 to 30 June 2020. Figure 39 shows the same for those incidents that result in a ground or vegetation fire.

Figure 38 Incidents on the CitiPower network

The numbers of incidents were higher in 2020-21 than the long-term average in three asset failure categories, lower in four categories and stable in one category. Contact incidents were lower in all categories except for tree contact events.

Fires from asset failures events were higher than the long-term average in two categories and lower than the long-term average in five categories. Fires from contact events were lower this year in all categories.

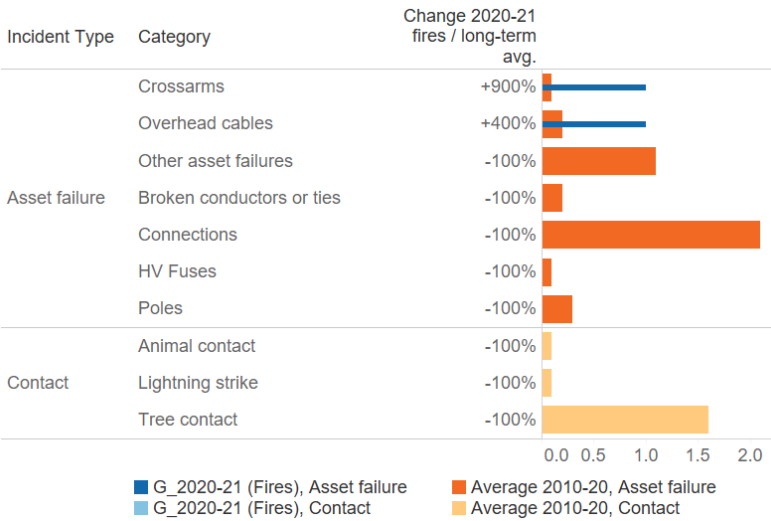
Figure 39 Incidents on the CitiPower network resulting in ground fires

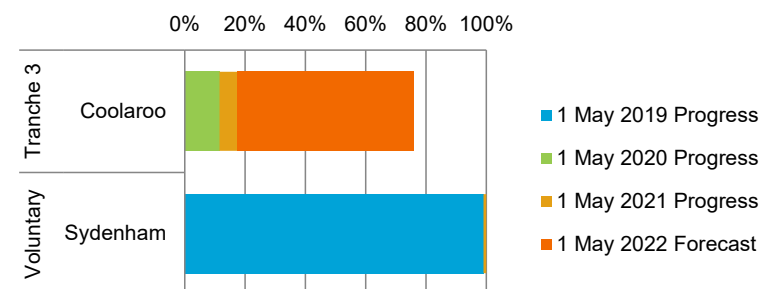
Figure 41 shows the progress of the Jemena REFCL installation program at 1 May 2019, 2020 and 2021, and its anticipated progress in the next 12 months.

Figure 41 Status of the Jemena REFCL program

¹² A base-level REFCL includes an arc suppression coil but does not include the power electronics that a complete REFCL uses for active fault compensation.

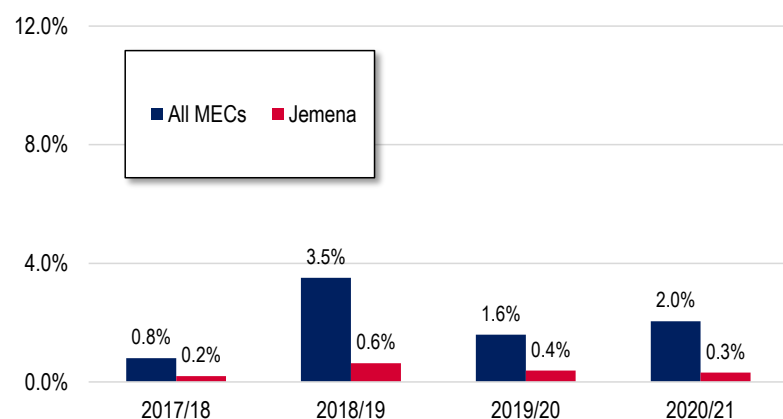
In 2020-2021 ESV observed further reduction of the already low rate of major non-compliance affecting the Jemena network. Figure 42 shows the combined rate of major non-compliances on the Jemena network.

Figure 42 Rate of major non-compliances (HBRA and LBRA)

The combined rate of major non-compliance on the Jemena network has been less than the average across all of the distribution networks since ESV began collecting this data in 2017. Jemena has also had the lowest rate of major non-compliances in three of the four years.

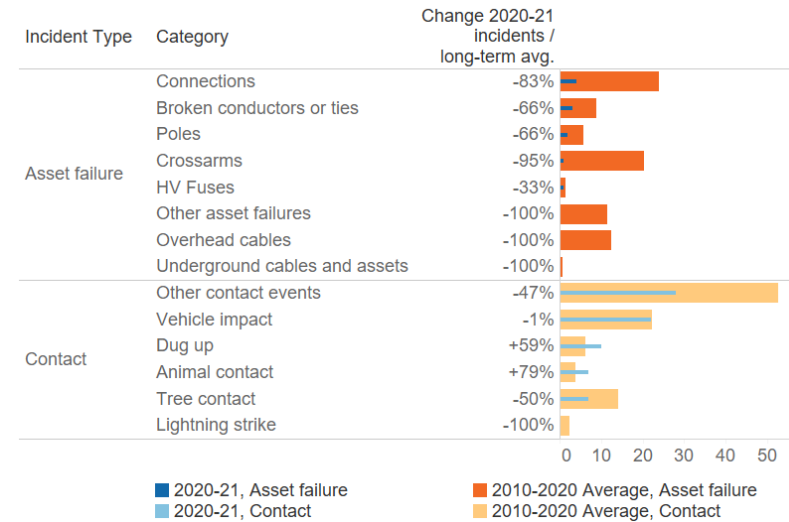
Figure 43 shows the number of all serious electrical incidents reported to ESV via OSIRIS by Jemena during the 2020-21 period, with the blue bars showing the numbers for 2020-21 and the orange bars showing the long-term average from 1 October 2010 to 30 June 2020. Figure 44 shows the same for those incidents that result in a ground or vegetation fire.

Figure 43 Incidents on the Jemena network

There were fewer asset failure events in all categories than tree contact incidents, which was the second best performing category of contact event.

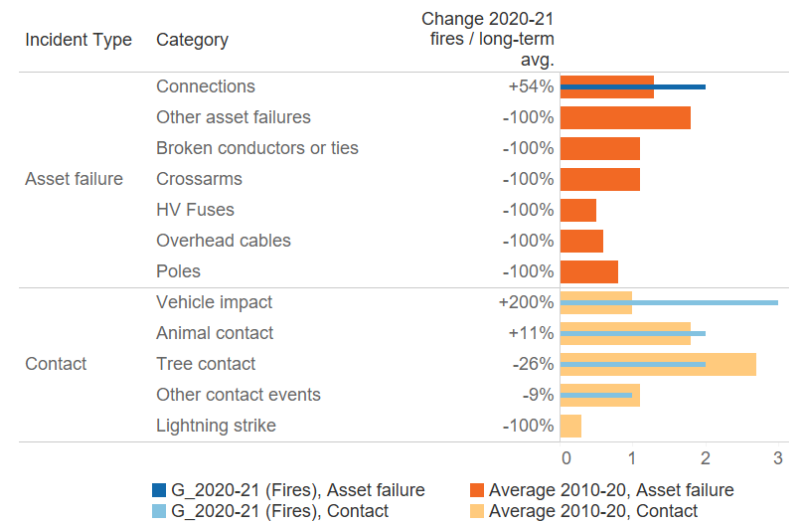
Figure 44 Incidents on the Jemena network resulting in ground fires

The most common fire incidents were vehicle impacts, connection failures, animal contacts and tree contacts. One of these is within the direct control of Jemena to manage, one is partly within its control and two are outside its control. Only vehicle impacts and connection failure fires were greater in 2020-21 than the long-term average.

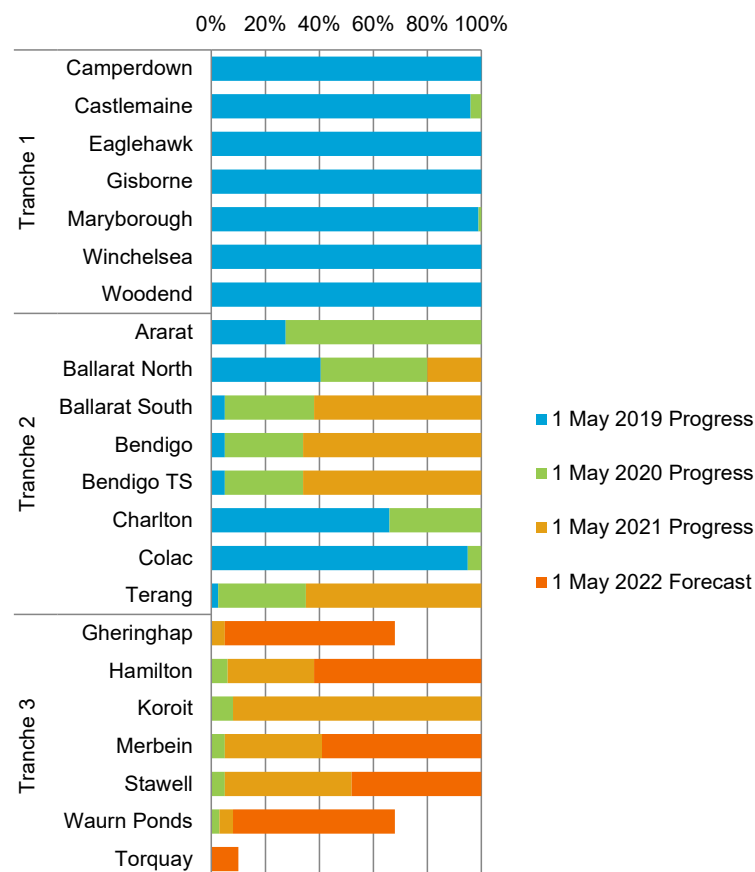
Figure 46 shows the progress of the Powercor REFCL installation program at 1 May 2019, 2020 and 2021, and its anticipated progress in the next twelve months.

Figure 46 Status of the Powercor REFCL program

By 30 June 2021, ESV had accepted sixteen zone substations as compliant.
