Safety performance report on Victorian electricity networks

November 2021

This report has been endorsed by the Victorian Energy Safety Commission.

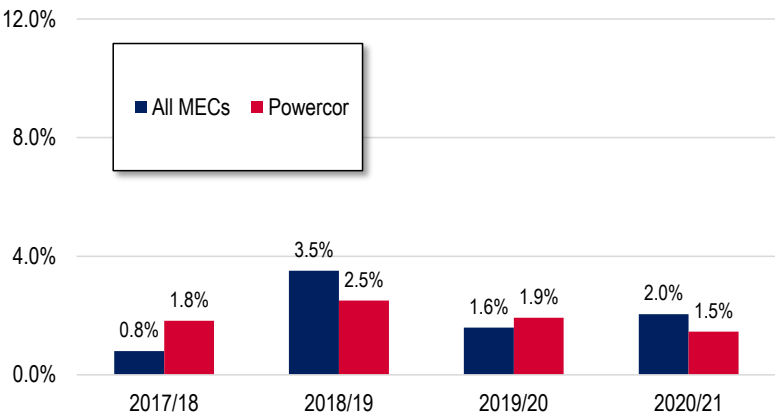
In 2020-21, ESV observed a steady decline in the overall rate of major non-compliance affecting the Powercor distribution network (Figure 47). The rate of major non-compliance on the Powercor distribution network was also lower than the average across all of the distribution networks for HBRA and LBRA combined.

Figure 47 Rate of major non-compliances (HBRA and LBRA)

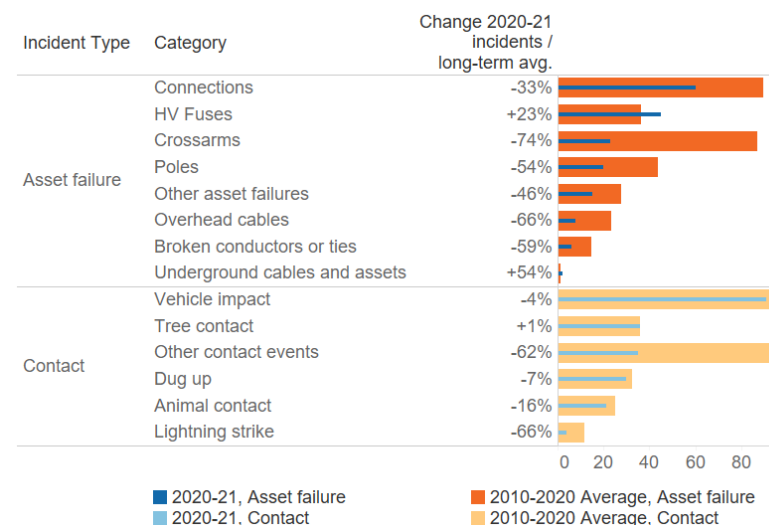
Figure 48 shows the number of all serious electrical incidents reported to ESV via OSIRIS by Powercor during the 2020-21 period, with the blue bars showing the numbers for 2020-21 and the orange bars showing the long-term average from 1 October 2010 to 30 June 2020. Figure 49 shows the same for those incidents that result in a ground or vegetation fire.

The most common incidents on the Powercor network in 2019-20 were vehicle impacts⁵, connection faults, HV fuse failures and tree contact. Two of these items are not within the control of the Powercor. The numbers of incidents were lower in 2020-21 than the long-term average in ten categories, stable in two categories and higher in two categories.

Figure 48 Incidents on the Powercor network

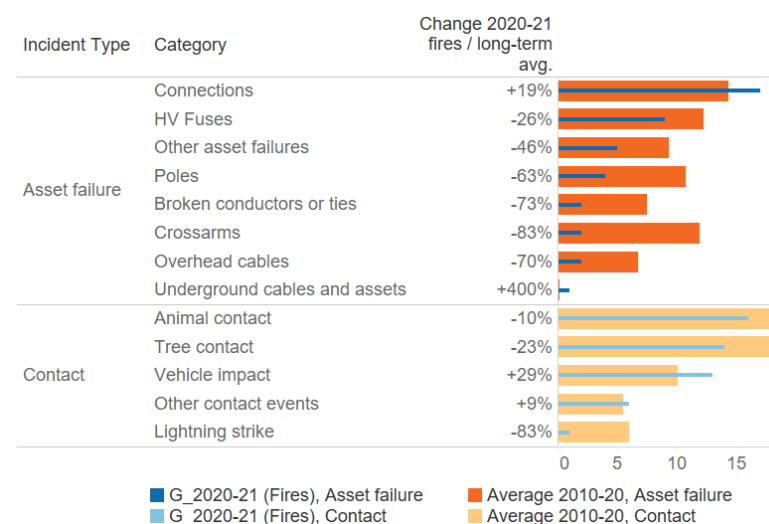
Connection faults, animal contact, tree contact, and vehicle impacts were the most common causes of network-related fires. One of these (connection faults) is within full control of Powercor to manage. While two are partially in its control (animal and tree contacts), the greater contribution to tree contacts is from branches blown or trees falling onto powerlines from outside the clearance space.

The numbers of fires in the period were also stable or lower than the long-term average of all categories except for connection faults, vehicle impacts and fires from other contact events.

Figure 49 Incidents on the Powercor network resulting in ground fires

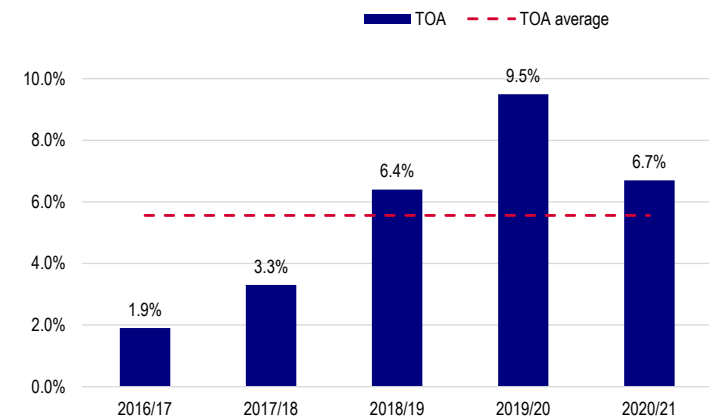
Last year, ESV noted that there had been a steady increase in the rate of non-compliant vegetation on this network each year since 2016-17. This year, we found the upward trend had been addressed with a reduced non-compliance rate being observed (Figure 52). This means ESV intervention will not be required provided TOA continues to maintain its improved performance.

Figure 52 Non-compliance rates for TOA

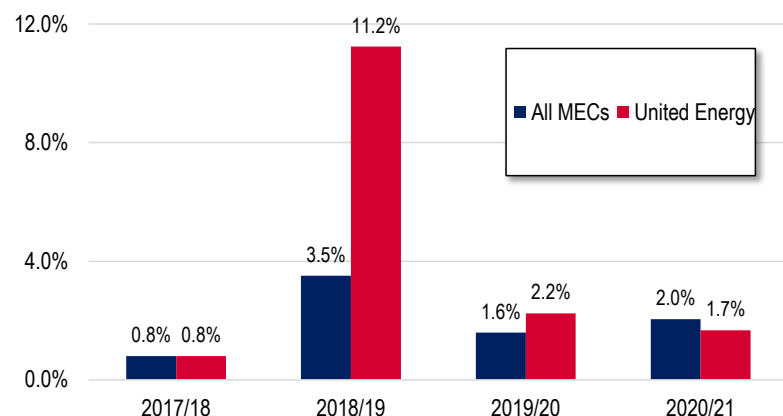
In 2020-21, ESV observed a decrease in the rate of major non-compliance affecting the United Energy network (Figure 55). The combined major non-compliance rate was lower than the average across all distribution networks.

Figure 55 Rate of major non-compliances (HBRA and LBRA)

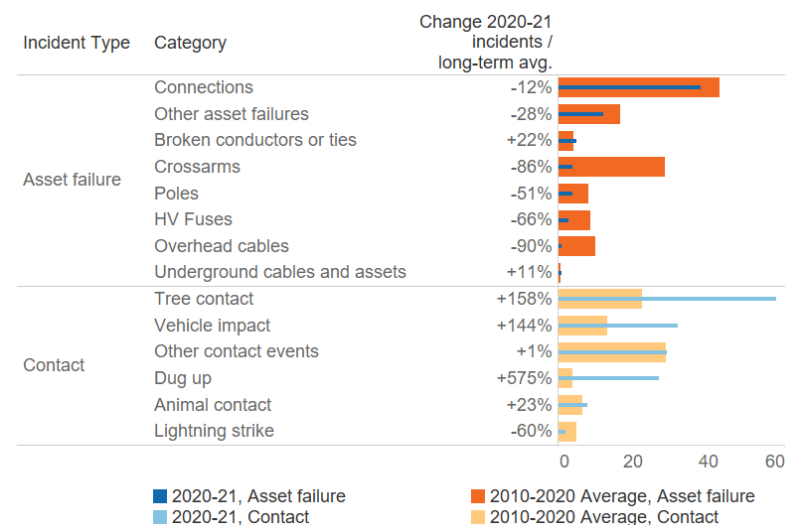
Figure 56 shows the number of all serious electrical incidents reported to ESV via OSIRIS by United Energy during the 2020-21 period, with the blue bars showing the numbers for 2020-21 and the orange bars showing the long-term average from 1 October 2010 to 30 June 2020. Figure 57 shows the same for those incidents that result in a ground or vegetation fire.

The numbers of all asset failure incidents were lower in 2020-21 than the long-term average, with the exception of broken conductors or ties. Contact events were lower in one category, stable in one category and higher in four categories.

Figure 56 Incidents on the United Energy network

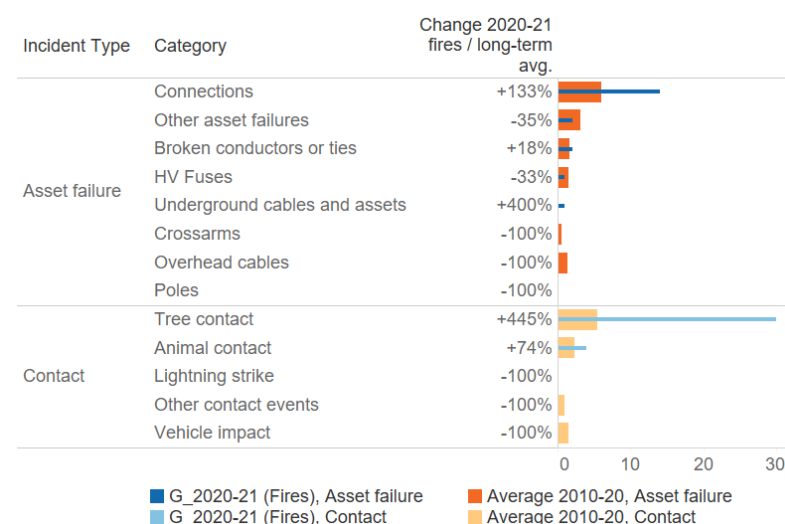
Tree contact, connection faults, animal contact and other asset failures were the most common causes of network-related fires. Two of these are within the full control of United Energy, and two are partially within its control (tree and animal contact). Fires are higher than the long-term average in five categories and lower in eight categories.

Figure 57 Incidents on the United Energy network resulting in ground fires

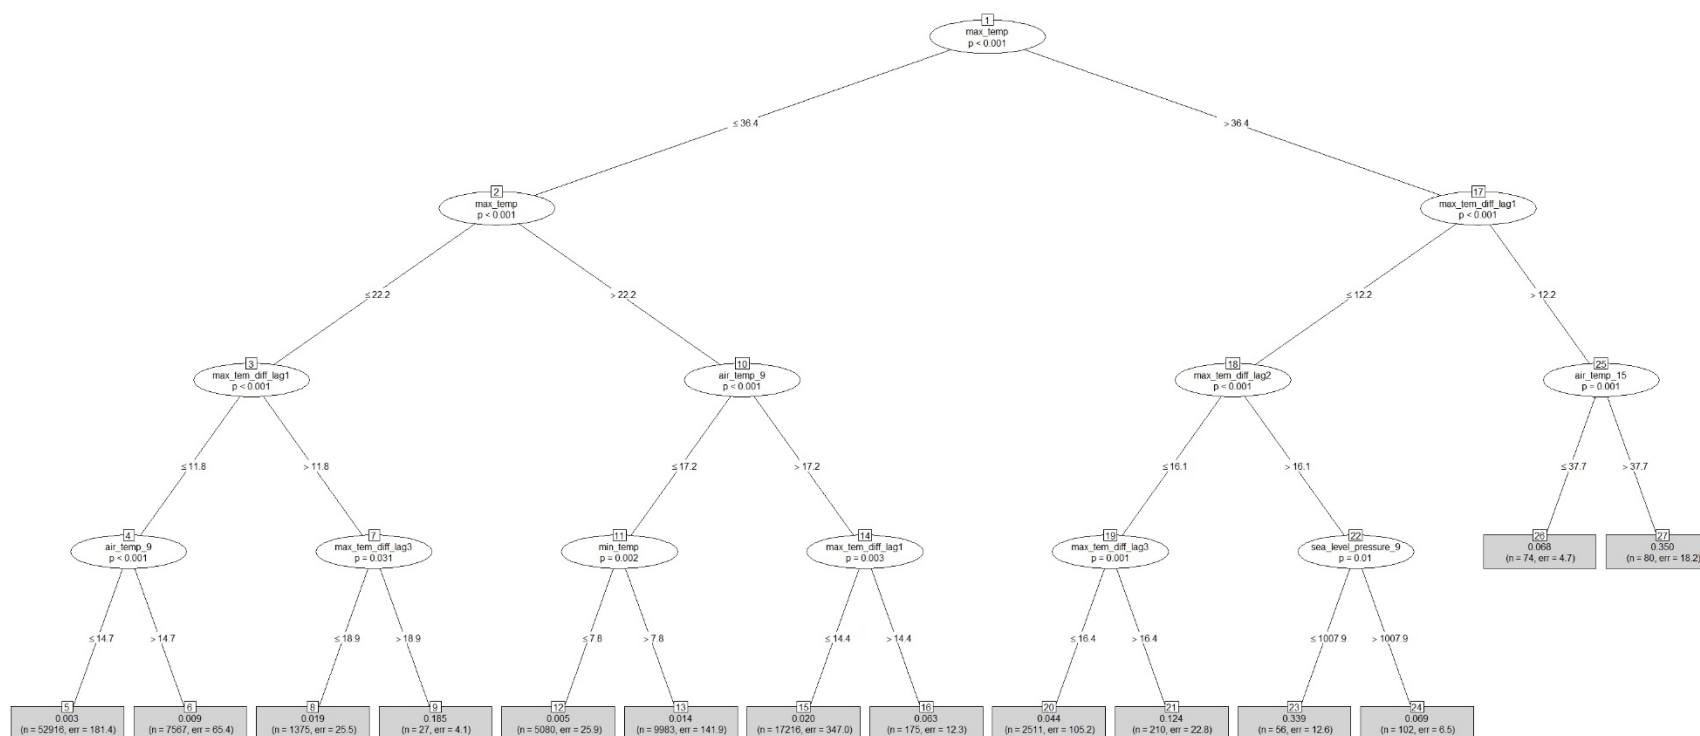
Figure 58 Partitioning of asset failure fires based on the contribution of different environmental factors

Asset failure fires were most likely to arise when the maximum daily temperature exceeded 36.4 degrees Celsius (Figure 58).

There was also contribution when the maximum temperature was less than 22.2 degrees Celsius, the temperature difference with the preceding day was more than 11.8 degrees Celsius and the difference with three days prior is more than 18.9 degrees Celsius.

The conditions that we determined would define an asset failure ‘at risk’ day comprised clusters 27, 23, 9, 21, 24, 26, and 20 in order from most to least importance.

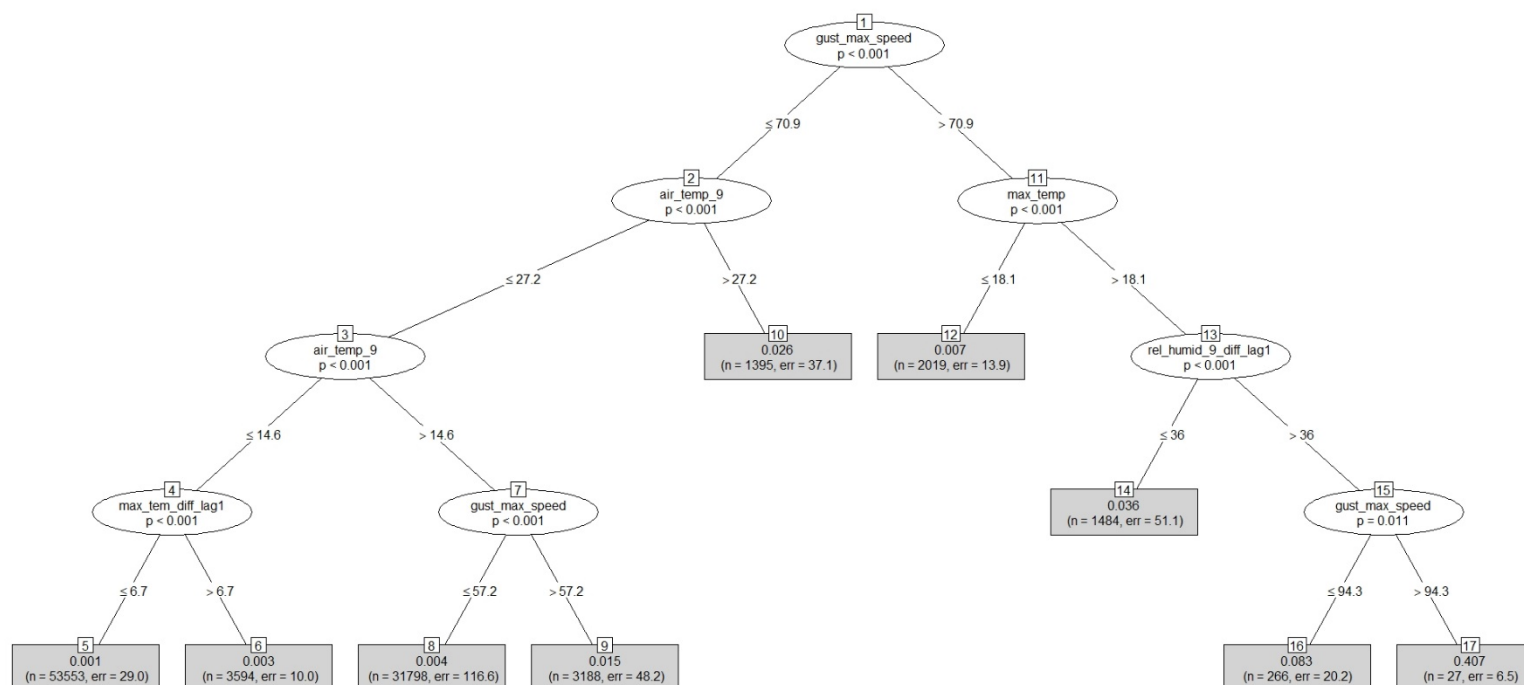
Figure 59 Partitioning of vegetation contact fires based on the contribution of different environmental factors

Vegetation contact fires were most likely to arise when the maximum wind gust was in excess of 70.9 km/h, the maximum temperature exceeded 18.1 degrees Celsius and the difference in morning humidity from the previous day exceeded 36 per cent (Figure 59).

The conditions that we determined would define a vegetation contact 'at risk' day comprised cluster 17 and 16 in order from most to least importance.

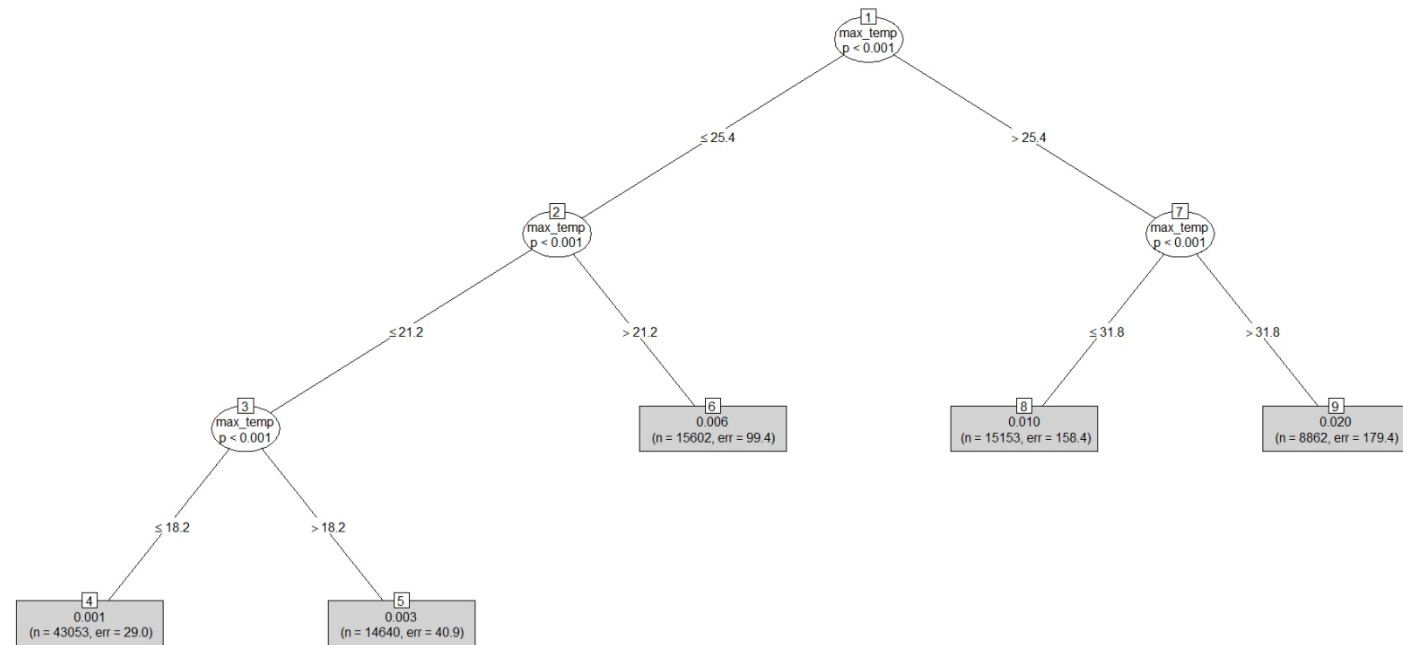
Figure 60 Partitioning of other contact fires based on the contribution of different environmental factors

Other contact fires were most likely to arise when the maximum daily temperature exceeded 31.8 degrees Celsius (Figure 60).
