# Safety performance report on Victorian electricity networks

October 2022

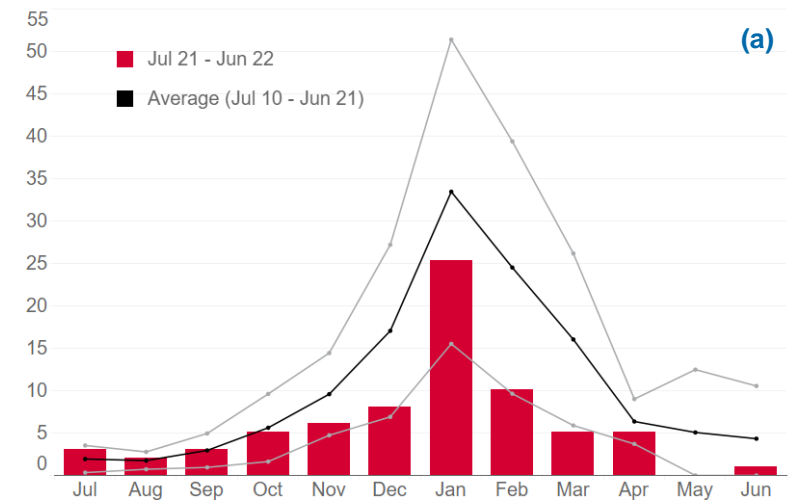
**Figure 2 Ground fire incidents due to (a) asset failures and (b) contact events**

The grey line is one standard deviation above and below the average

The averages and bounds in Figure 2 show a clear seasonal trend in ground fires due to both asset failures and contact events. Throughout most of the year, there are similar numbers of fires from asset and contact events; however, there is a more pronounced peak in asset-related ground fires in January and February.

The numbers of asset-related ground fires (red bars in Figure 2a) were within one standard deviation of the 2010-2020 average for most of the year. The exceptions were February and March, which had fewer fires than expected. The number of fires across the bushfire season (November to April) were below the long-term average for each month.

Figure 2b shows that the numbers of contact-related fires were well in excess of the historic numbers in October and January. The numbers of fires across most of the bushfire season were below the historic average, with the exception of January.

The outliers in Figure 2b are the peaks in January 2022 and October 2021 that are well above the normal band of expected fires.
