Safety Performance Report
on
Victorian Electricity Distribution
and
Transmission Businesses
2012

JUNE 2013

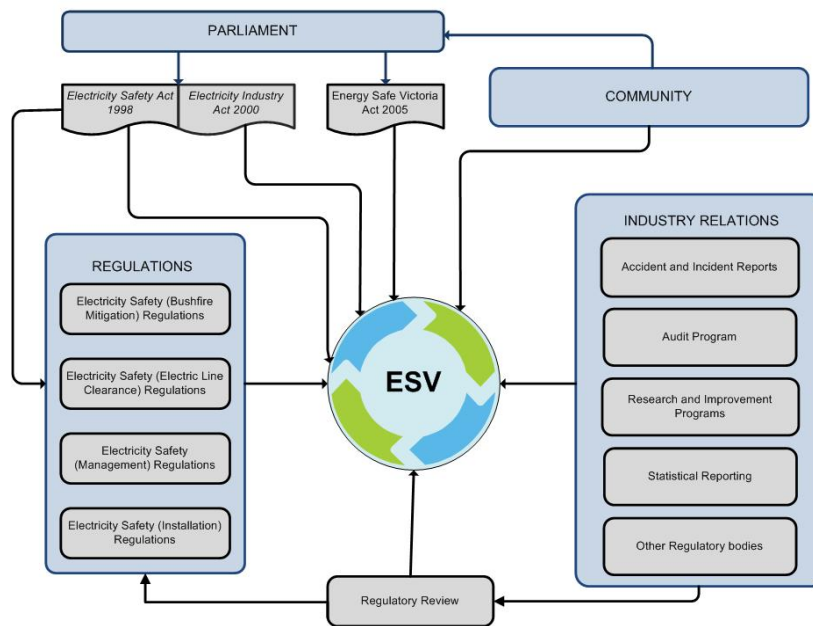
Figure 1: ESV's approach to MEC electricity safety management

ESV's regulatory approach to electricity network safety management is depicted in Figure 1, and the key elements are expanded below.

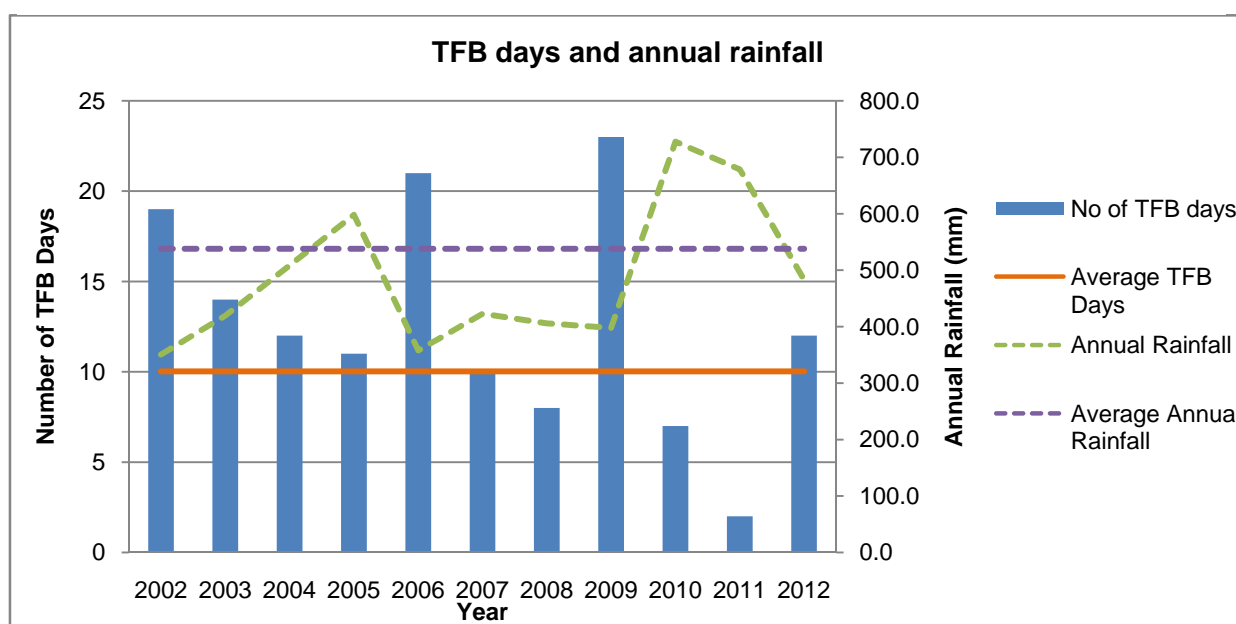
Figure 15: Number of TFB Days declared by CFA and annual rainfall data

In addition to network performance, weather conditions influence the number of fires that may be initiated. The weather in 2012 was hotter and drier than the previous two years, with more TFB days. Some of the increase in the number of fires in both vegetation and power poles/crossarms can be attributed to the prevailing weather conditions over the 2012 summer increasing the probability of fire ignition.

[Melbourne Airport; recent data from the Bureau of Meteorology; annual rainfall, the number of TFB days declared by the CFA (used as a proxy to indicate dry conditions) and the long-term (40-year) averages.]
