# Section 8 Committee

13 June 2017

# **REFCL Trials – Current Status**

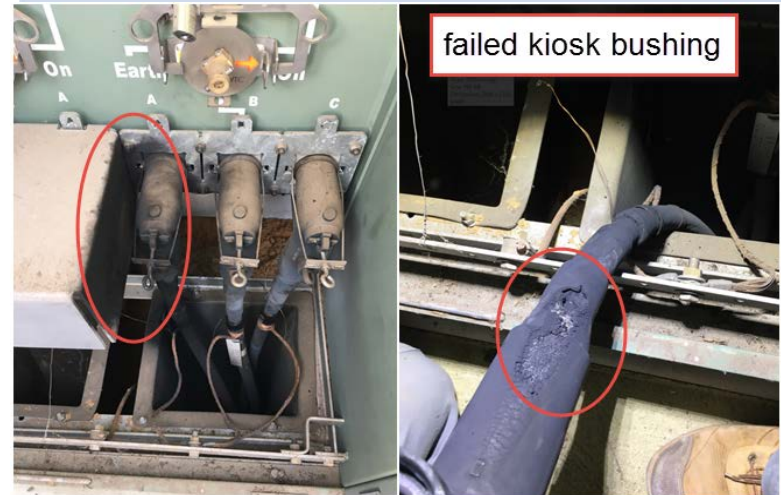
## WND REFCL

- Network stress testing completed on all 22kV buses without major incident
  - Two blown surge arrestors (only 1 found – Bowthorpe 24kV)
- Problems experienced during performance standard testing (U/G faults x 2, kiosk bushing failure, feeder CTs require replacement)
- Commissioning on hold until repairs are completed and replacement CTs are sourced and implemented

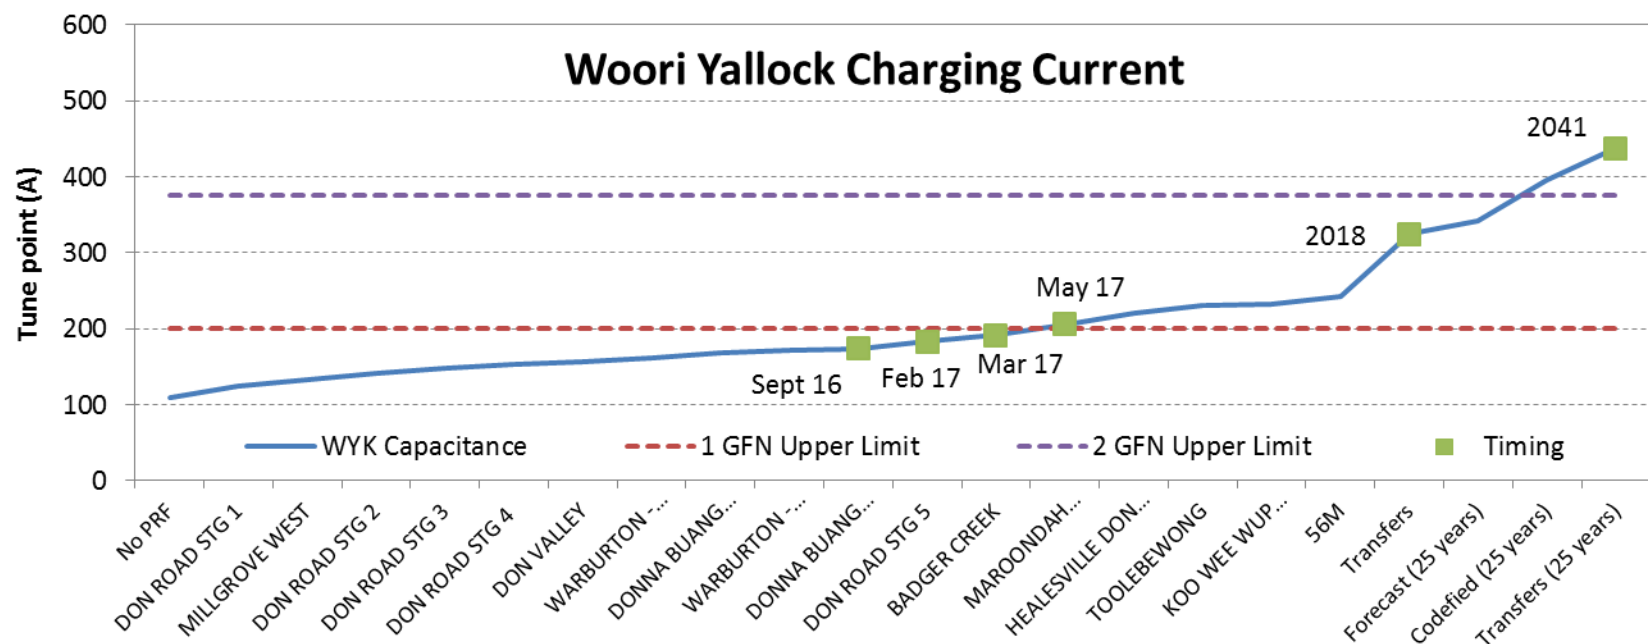
- ▶ **PRF (undergrounding) works have been impacting on capacitance of WYK network**
  - › Load transfers have been used to keep REFCL operating to date
  - › Options have been exhausted so REFCL will stop operating at the end of June
- ▶ **Design commenced on 2<sup>nd</sup> REFCL**
  - › Expected to be in service by April 2018

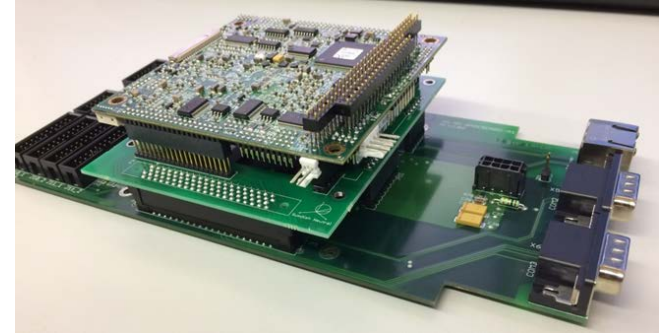
- ▶ **The WYK GFN experienced 2 major hardware failures over the last 2 months:**
  - › Processor card failure on the 18th of April
  - › Inverter contactors locked up on the 2nd of May

- ▶ **For each failure, the GFN taken out service for a period of up to 10 days to carry out fixes. Manufacturer informed of failure and sent faulty parts for further investigation.**
- ▶ **Troubleshooting manual developed internally in the event of future failures.**
- ▶ **Since the GFN was put back in service on the 7th of May, the Woori Yallock network experienced 7 transient faults. GFN operated as expected for these faults.**

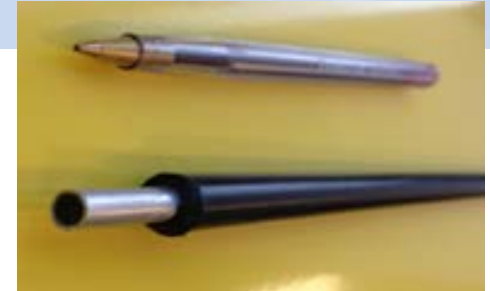
- **3<sup>rd</sup> pilot project of LoSAG experienced a conductor failure during final tensioning**
- **Project located at Chaplains Creasy**
- **Three project exemptions with ESV currently in place**
- **Joint investigation and further testing with manufacturer**
- **Issue appears to relate to performance of insulation under high heat situations**
- **All LoSAG work suspended until thorough due diligence completed.**
- **Unclear if this is a fundamental design flaw or able to be rectified.**
