# **Powercor Wood Pole Management**

## **An assessment of sustainable wood pole safety outcomes**

## **Public Technical Report**

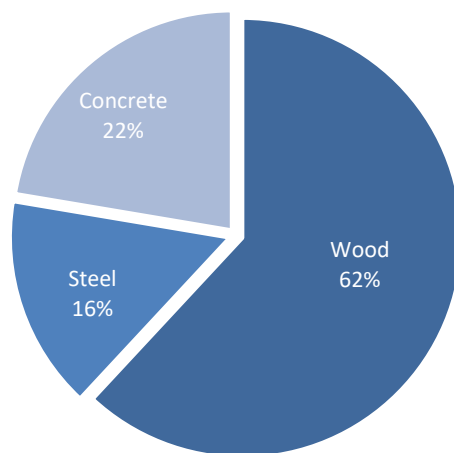
**Figure 2 Composition of pole materials**

The population of power poles is predominantly of wooden construction (365,900, 62 per cent) of which 58 per cent (212,200) are located in HBRA, as shown in the figures below.

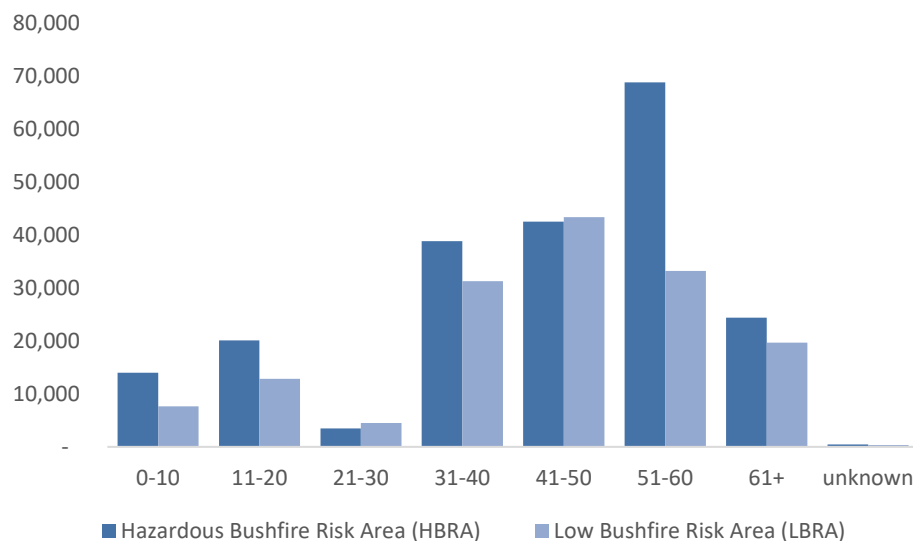
**Figure 4 Age profile of wood poles installed by bushfire risk area as at 2019**

The average age of the wood pole population is 44 years, with 53 per cent (194,000) already over 45 years of age. The distribution of wooden power poles by age and by bushfire risk area is shown in Figure 4.

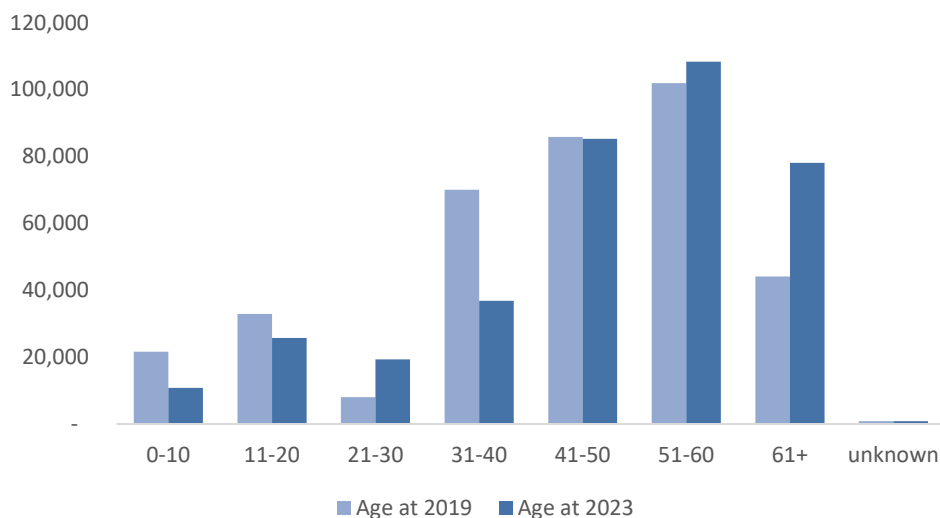
**Figure 5 Age of wood poles installed as at 2019 and 2023**

To provide an indication of the increasing age profile, when the age of each wood pole is increased by five years (without replacement), by the year 2023, the largest increase is to the poles in the 61+ years category.

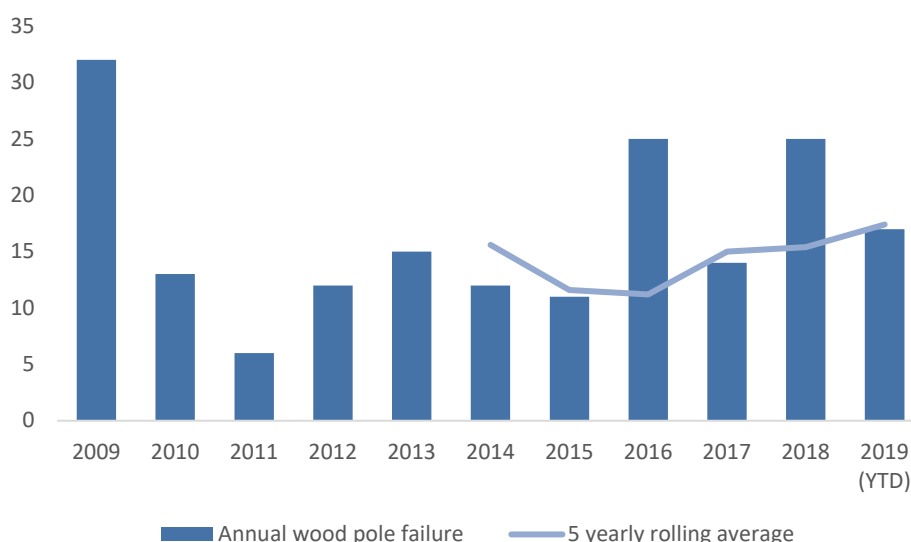
**Figure 6** Powercor's wooden pole failures

The number of wooden pole failures shows an increasing trend over the last few years as illustrated in the Figure 6. Powercor sets a threshold and monitors the performance of wooden pole failures based on Powercor's five-year rolling average, which can be seen to be increasing since 2016.

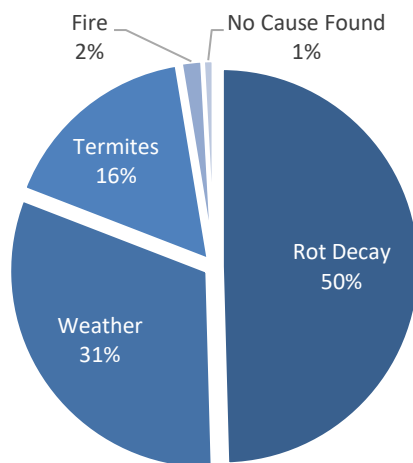
**Figure 8 Cause of wood pole failures**

Without intervention the failure rate will continue to increase as poles age. The major causes of unassisted wooden pole failure are rot decay (50 per cent) followed by weather (31 per cent) and termites (16 per cent) (refer Figure 8). Unassisted pole failures occur when the pole is no longer able to withstand the forces it was designed to withstand (such as wind and the weight of power line conductors).
