Cut branch contacts LV electric line

Vegetation Management Work

17 May 2022

Safety alert

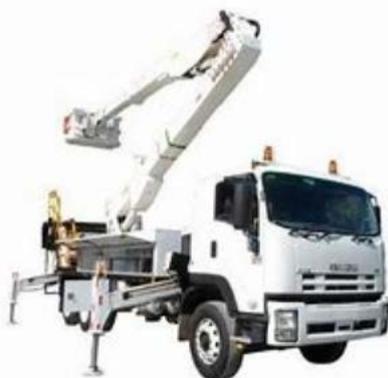
A vegetation management worker was removing a tree on behalf of a property owner in a low bushfire risk area (LBRA). The work was being performed by a vegetation management worker operating an elevated work platform (EWP) similar to that pictured below, example pictured.

The vegetation management worker (EWP operator) was pruning branches from the tree with the intention of removing the whole tree. There was no safety observer on site. One of the pruned branches fell in an uncontrolled manner and made contact with an uninsulated low voltage (LV) conductor. The LV conductor clashed with a second LV conductor. This caused the conductors to spark and affected electricity supply.
